VIN: 3AKJGLD52FSGL6241

2015 FREIGHTLINER CASCADIA

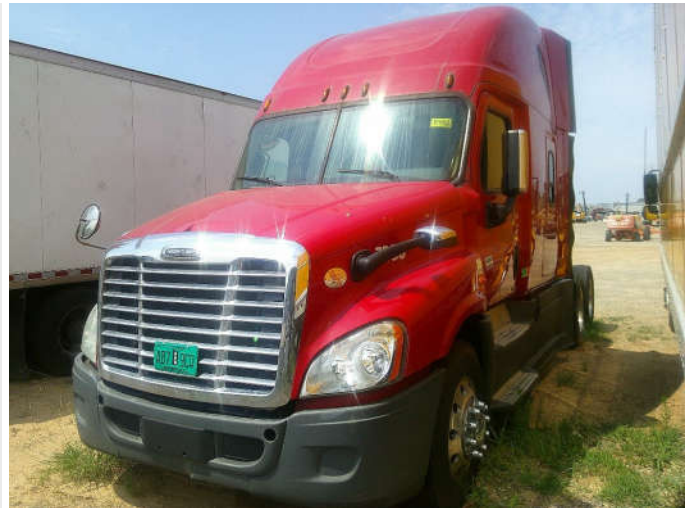
ENGINE TURNED OVER BUT WOULD NOT START. APU NEEDS SERVICE. CHIPPED WINDSHIELD AT BOTTOM. UNIT TOWED TO FACILITY/ SEEPAGE AT BOTTOM OF BLOCK / OIL PAN.

WEAR & TEAR DETAIL	
DIAGNOSTICS	2 ACTIVE, 11 INACTIVE - SEE REPORT
INTERIOR	DIRTY
TIRES	7 BELOW 10/32'S
WHEELS	HUB COVER MISSING
FAIRINGS	MISSING RUBBER SKIRTS
BUMPER	SCUFFED / SCRATCHED
SLEEPER	CABINETS MISSING RIGHT SIDE, VARIOUS PARTS IN CAB
1/4 FENDERS	DAMAGED
MUD FLAP	LEFT SIDE MISSING
