National Inspection Services

Report: 272116 08/21/2024

VIN: 3AKJGEBG4HSJA7899

2017 FREIGHTLINER CASCADIA 125 T/A

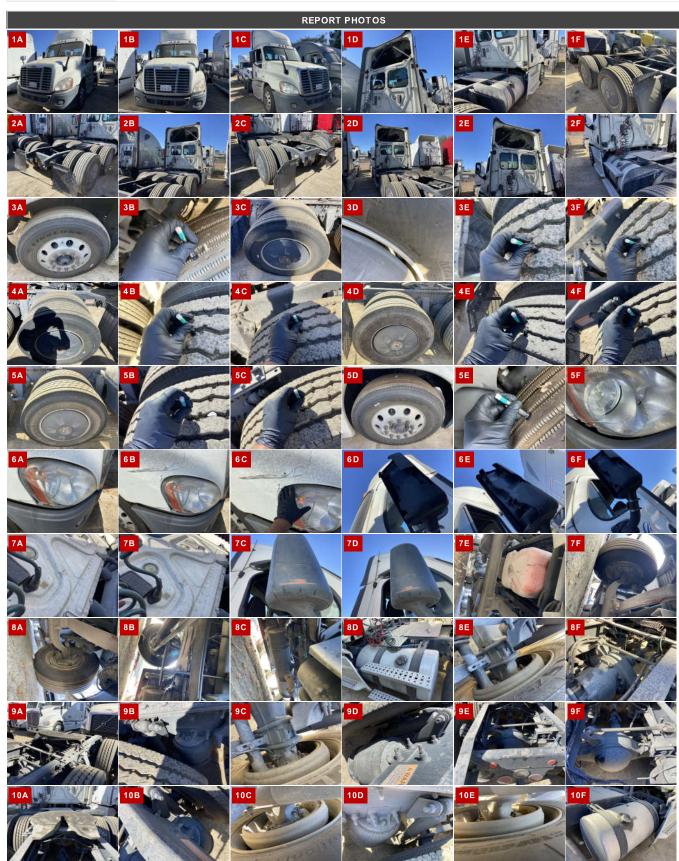
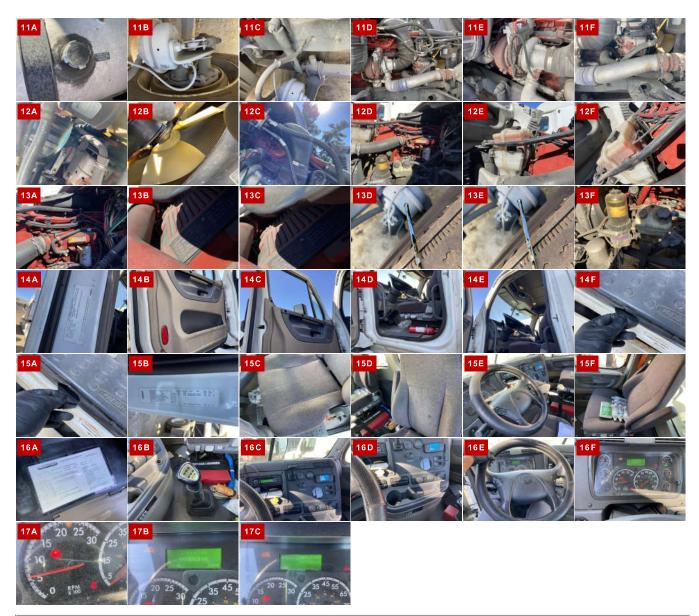
WEAR & TEAR DETAIL		
DIAGNOSTIC	CHECK ENGINE AND STOP ENGINE LIGHTS ARE ON. 1 ACTIVE FAULT / 19 INACTIVE FAULTS FOUND - (SEE ECM REPORT)	
DRIVER DOOR SEAL	TORN NEAR THE FLOOR AREA.	
HEADLIGHTS	RIGHT HEADLIGHT LENS BROKEN.	
HOOD	THE HOOD IS HEAVILY CRACKED ON THE RIGHT SIDE ABOVE THE HEADLIGHT.	
MIRRORS	LEFT MIRROR HOUSING COMPLETELY CRACKED.
