Commercial Credit Group, Inc (Mark Wenzel)
525 N Tryon Street, Charlotte, NC 28202 USA
(704) 414-2456

VIN: 3ALACWFC4KDKH6725
PO #: 15142

2019 FREIGHTLINER M2

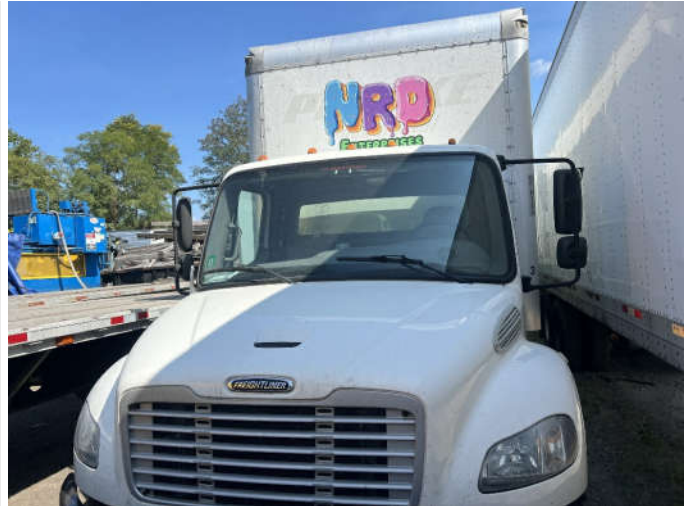
ENGINE OIL LEAK AT THE REAR OF THE OIL PAN

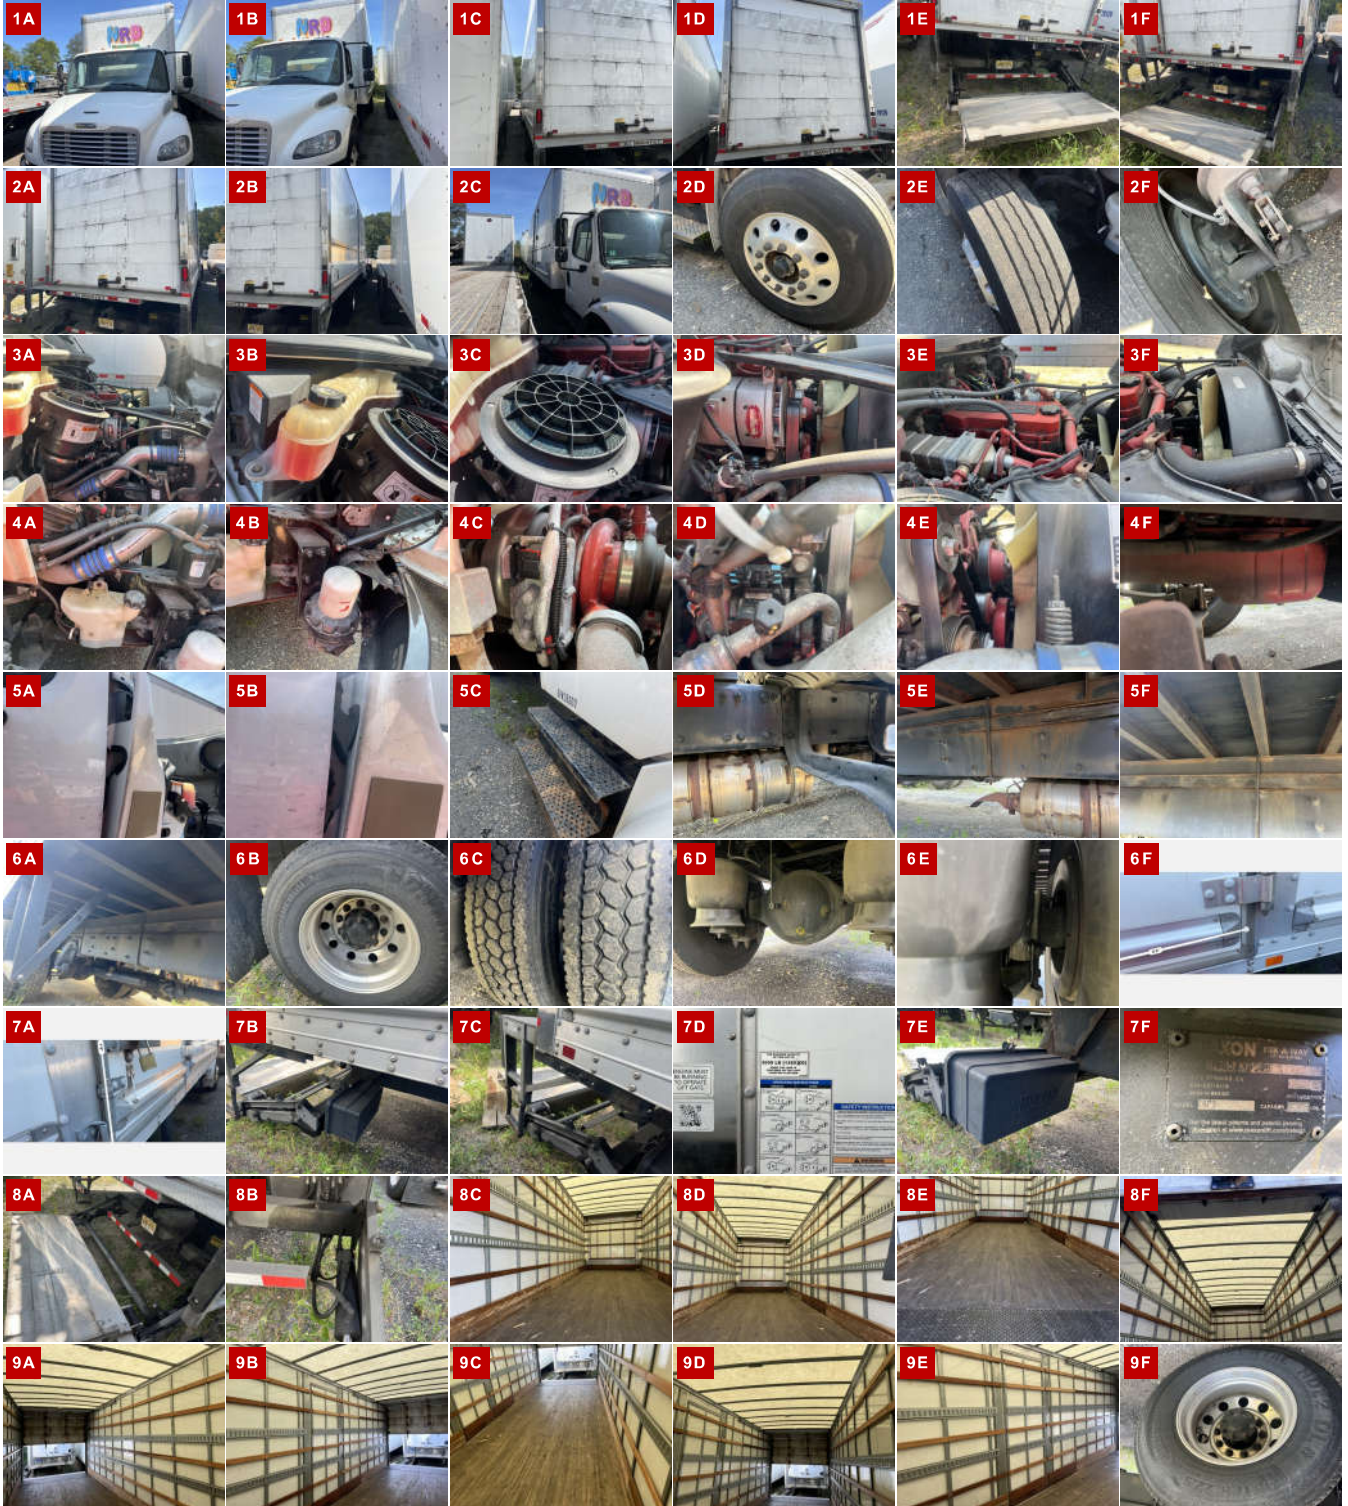
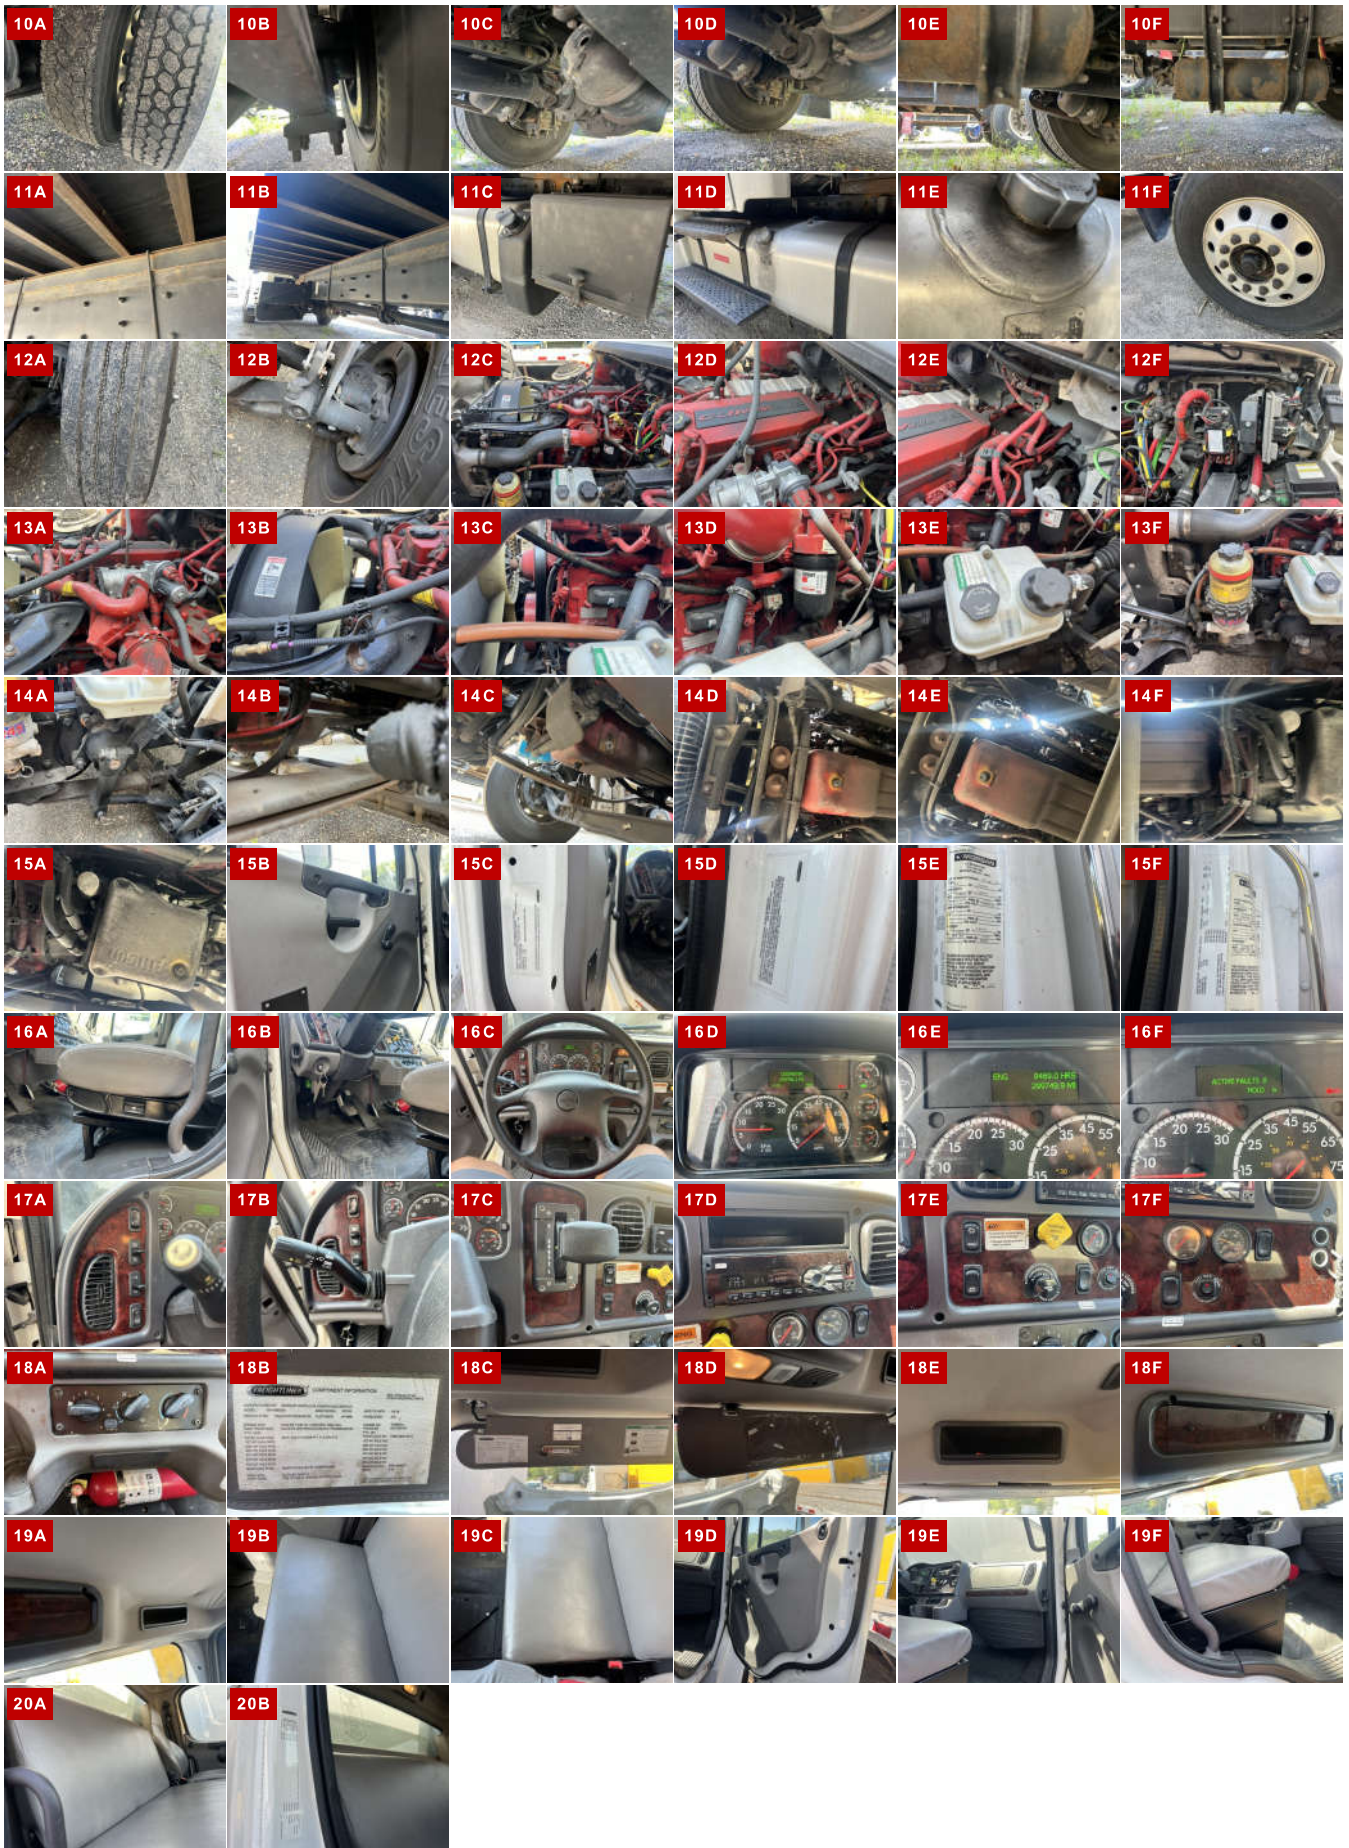
DIAGNOSTICS	CHECK ENGINE LIGHT ILLUMINATED 18 INACTIVE FAULTS DETECTED - (SEE ECM REPORT)
COWL	BROKEN AND PULLING AWAY FROM BODY ON THE P/S
LIFTGATE	LIFTGATE DOES NOT GO UP AND DOWN. MOTOR WORKS BUT DOES NOT MOVE.
HEADLINER	STAINED IN VARIOUS AREAS FALLING DOWN IN THE CORNERS
STEERING WHEEL	SURFACES HAVE WEAR
INTERIOR BOX	SCRAPES AND RUB MARKS
