National Inspection Services

Report: 269530 07/19/2024

VIN: 5WKBE3634P1079572

2023 OTHER FREEDOM 8.5X36 TTA4

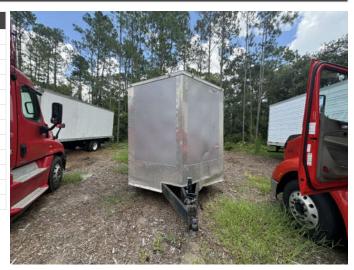
EXTERIOR BOX DENTED ON THE FRONT D/S. D/S REAR PANEL IS LOOSE. SCRAPED AND DENTED ON THE P/S. DOOR COVERED UP WITH DIAMOND PLATE ON D/S. LARGE CRACK IN THE P/S WALL. MULTIPLE DOOR HANDLES ARE DAMAGED. RIVETS MISSING ON BOTH SIDES

INTERIOR BOX FLOOR IS STAINED, FRONT WALL IS DENTED. LEAKING ALONG THE D/S REAR
