**Commercial Credit Group, Inc (Mark Wenzel)**  
525 N Tryon Street, Charlotte, NC 28202 USA  
(704) 414-2456

VIN: 1XKYDP9X6HJ145781  
PO #: 15118

**2017 KENWORTH T680**

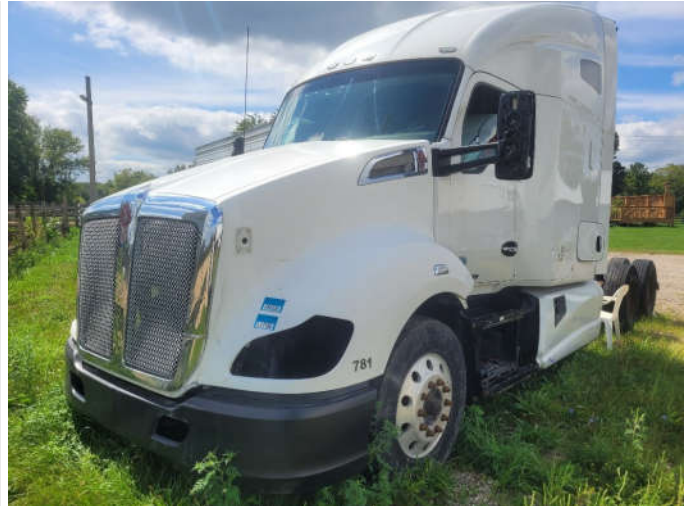
NO BATTERIES, UNABLE TO START AND TEST. ENGINE IS DISASSEMBLED, MANY PARTS ARE INSIDE ON CAB FLOOR.

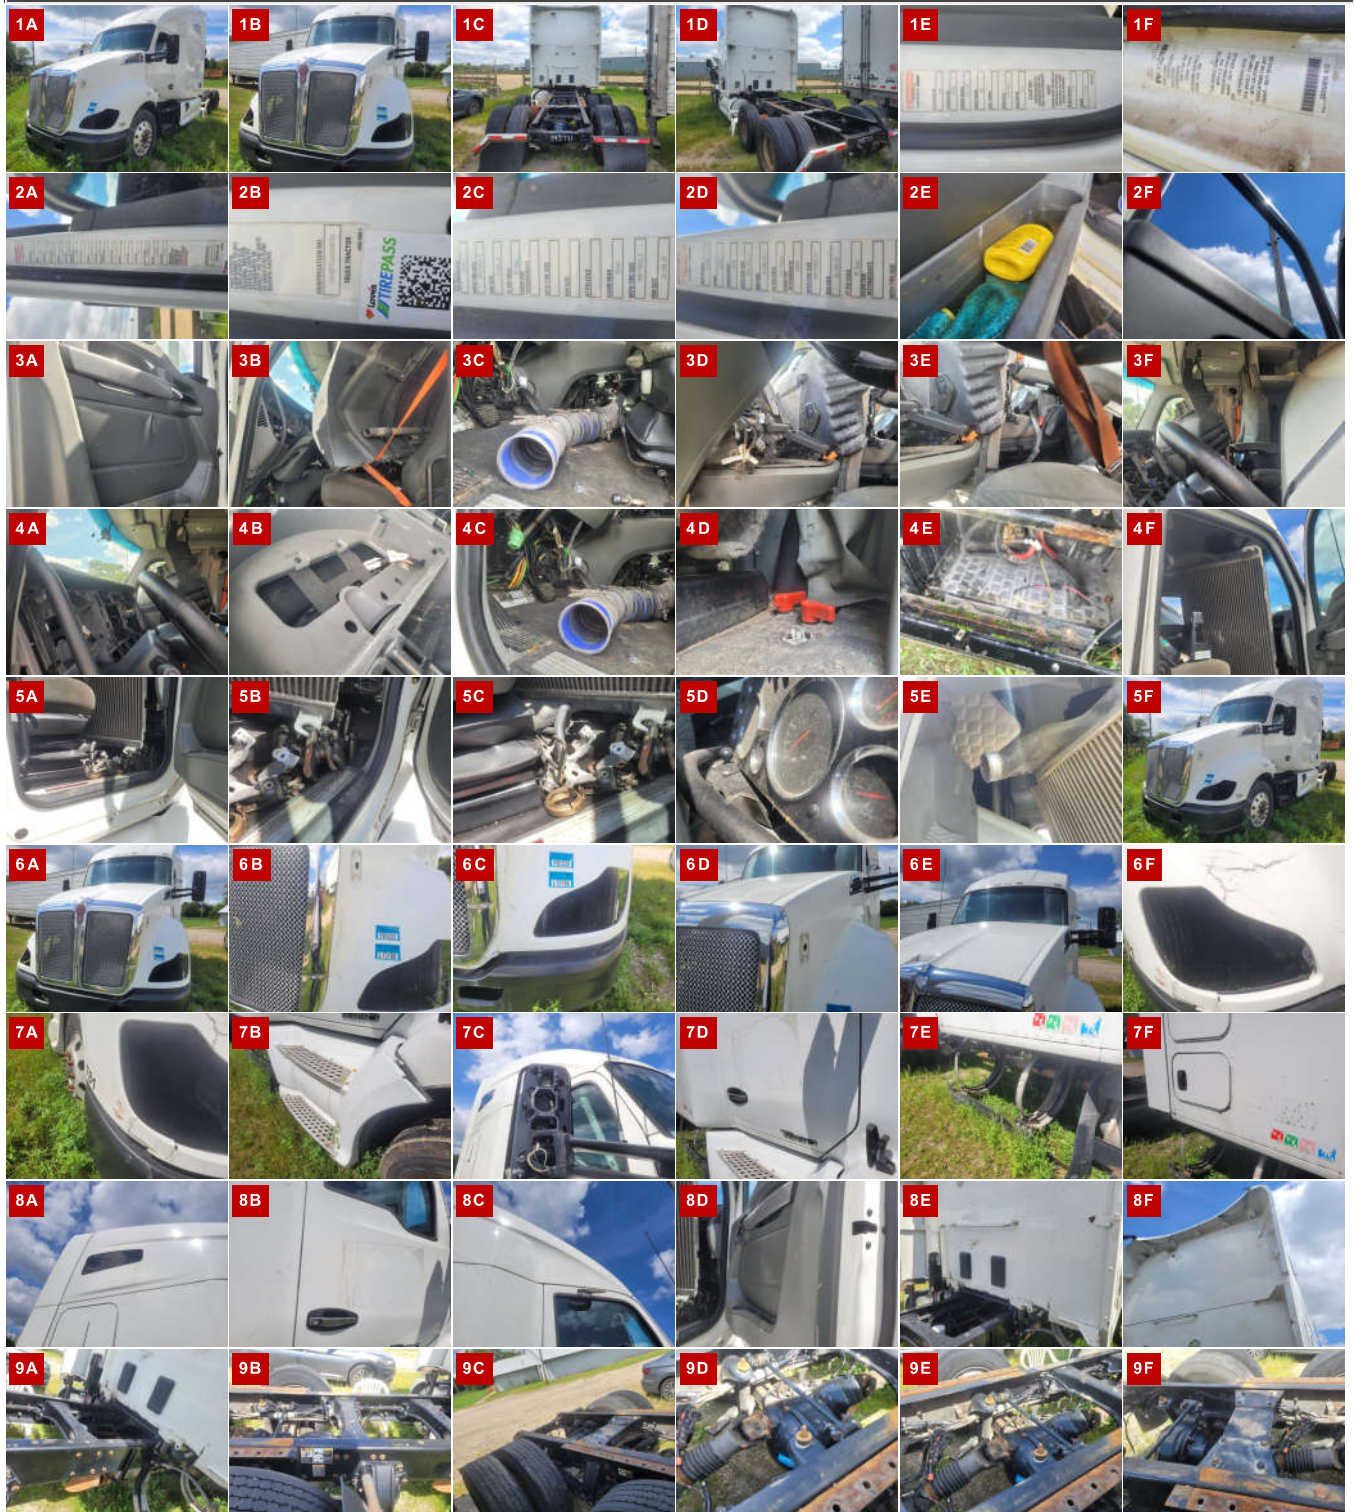
**REPORT PHOTOS**

<b>GENERAL NOTES</b>	UNIT IS INOPERABLE INSTRUCTED TO INSPECT AS IS
<b>ENGINE</b>	ENGINE IS TORN APART MANY MISSING PARTS COMPLETELY INOPERABLE
<b>INTERIOR</b>	NO INTERIOR PICS CAB IS FULL OF MISSING ENGINE PARTS
<b>HOOD</b>	CRACKS ON BOTH SIDES
<b>MIRRORS</b>	HOOD MIRRORS ARE MISSING AND BOTH SIDE MIRRORS ARE MISSING COVERS.
<b>GRILLE</b>	GRILLE IS DAMAGED ON LEFT SIDE
<b>FUEL TANK</b>	PASSENGER SIDE FUEL TANK IS MISSING
<b>FAIRINGS</b>	DRIVER SIDE STEP FAIRING IS MISSING AND PASSENGER SIDE TANK FAIRING IS MISSING.
<b>SUSPENSION</b>	AIR RIDE BAGS ARE MISSING
<b>TIRES</b>	LEFT 1ST AXLE INNER TIRE AND WHEEL ARE MISSING
