VIN: 1XKYD49X9LJ344721
PO #: 15207

2020 KENWORTH T680

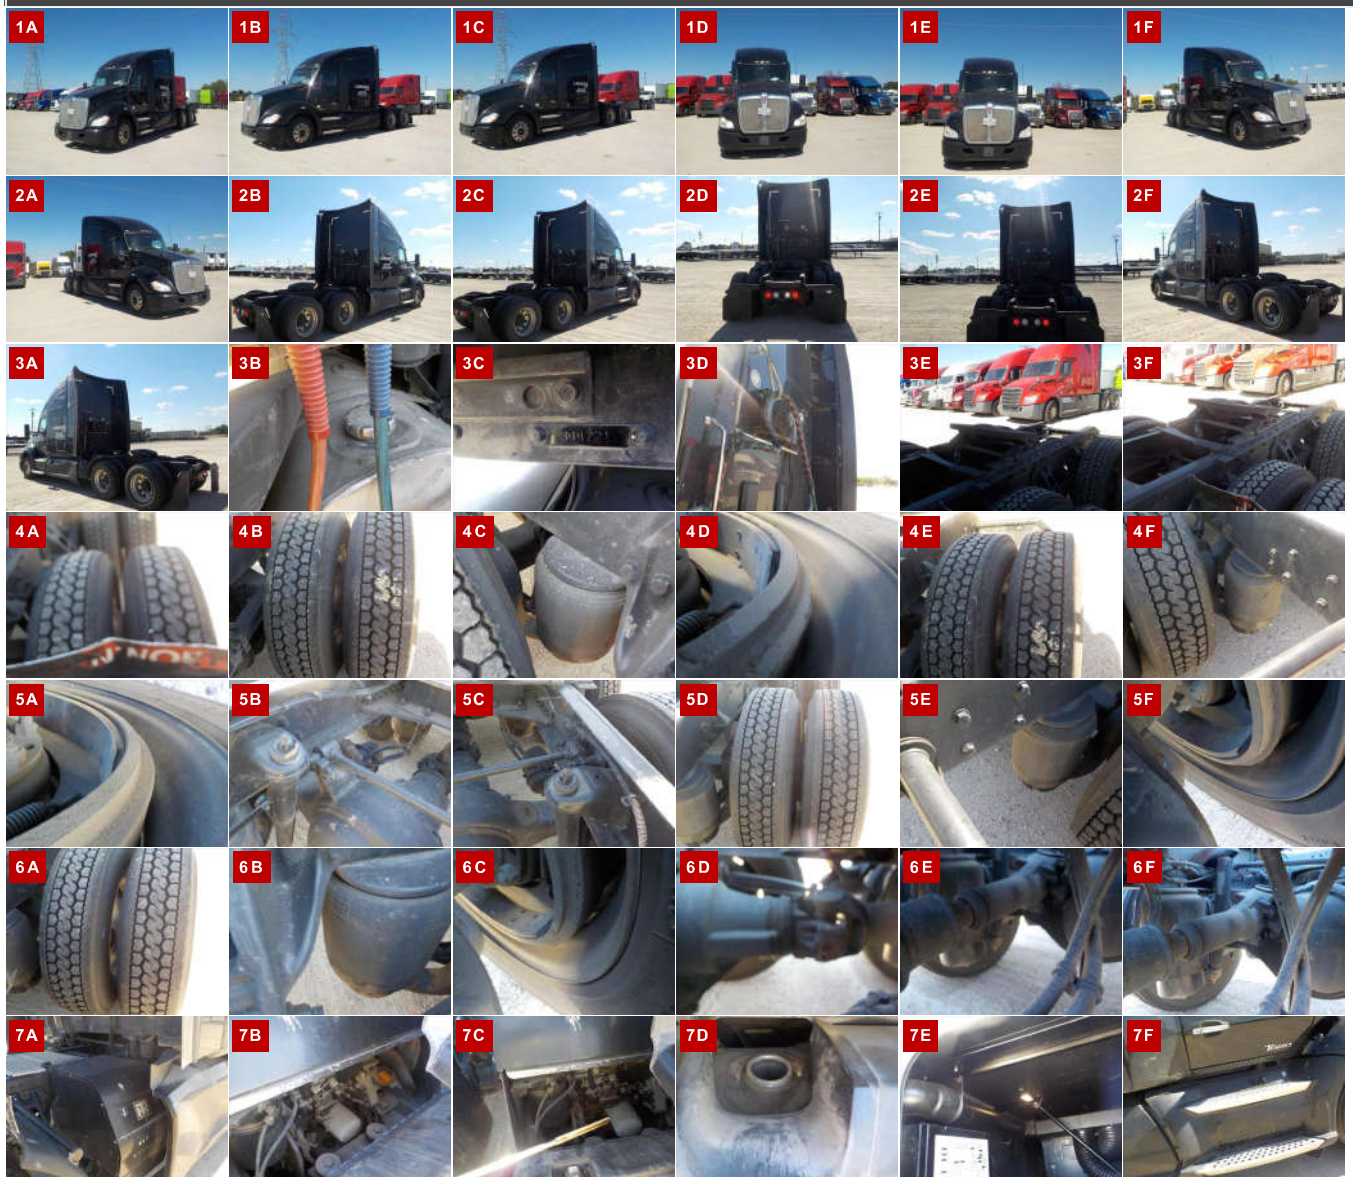
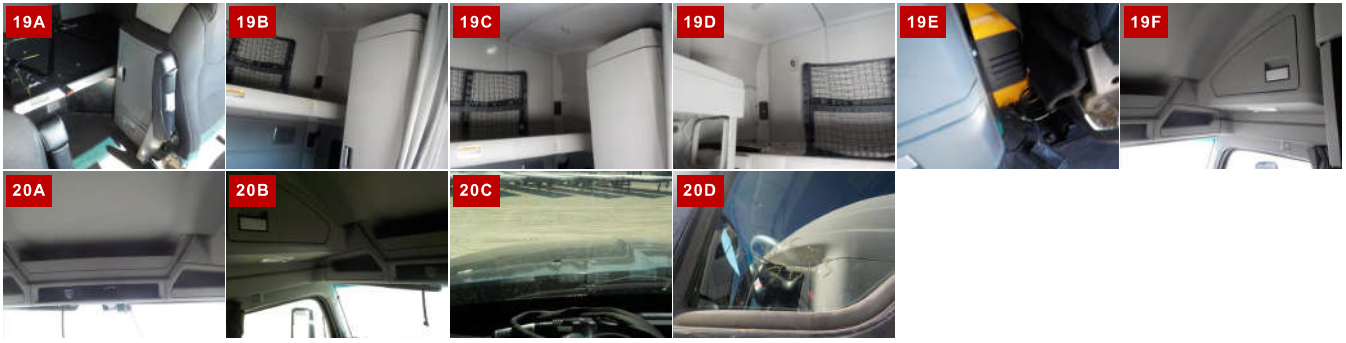
REPORT PHOTOS

DPF FAIL: SPN 4375 FMI 2 - AFT 1 SCR CATALYST REAGENT PUMP DRIVE PERCENTAGE.

DIAGNOSTICS	TRACTION CONTROL, TIRE PRESSURE AND HILL ASSIST LIGHTS ARE ON. 9 ACTIVE AND 16 INACTIVE CODES - SEE ATTACHED REPORT
PAINT	VARIOUS CHIPS AND SCRATCHES
FUEL TANK	RIGHT SIDE CAP MISSING
APU	CRANKS WILL NOT START
SEATS	SHOWING SIGNS OF WEAR
WINDSHIELD	CRACKED AND STONE CHIPPED
CAB/SLEEPER	NEEDS CLEANING AND DETAIL
