VIN: 3AKJGLD52FSGL6241

2015 FREIGHTLINER CASCADIA

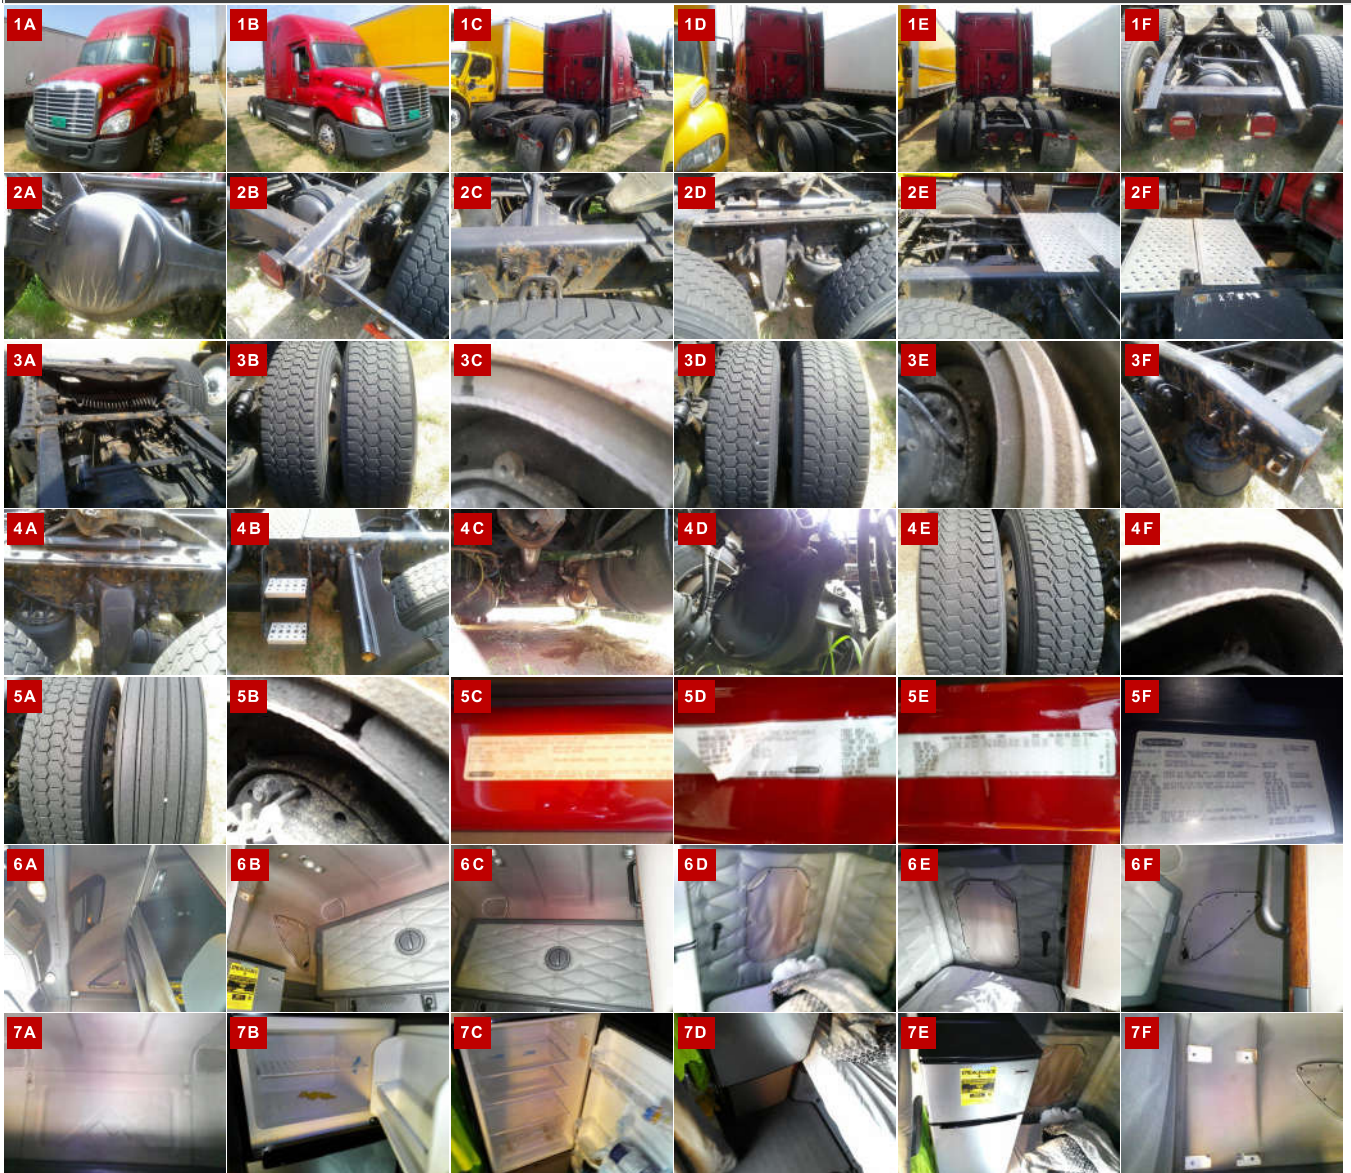
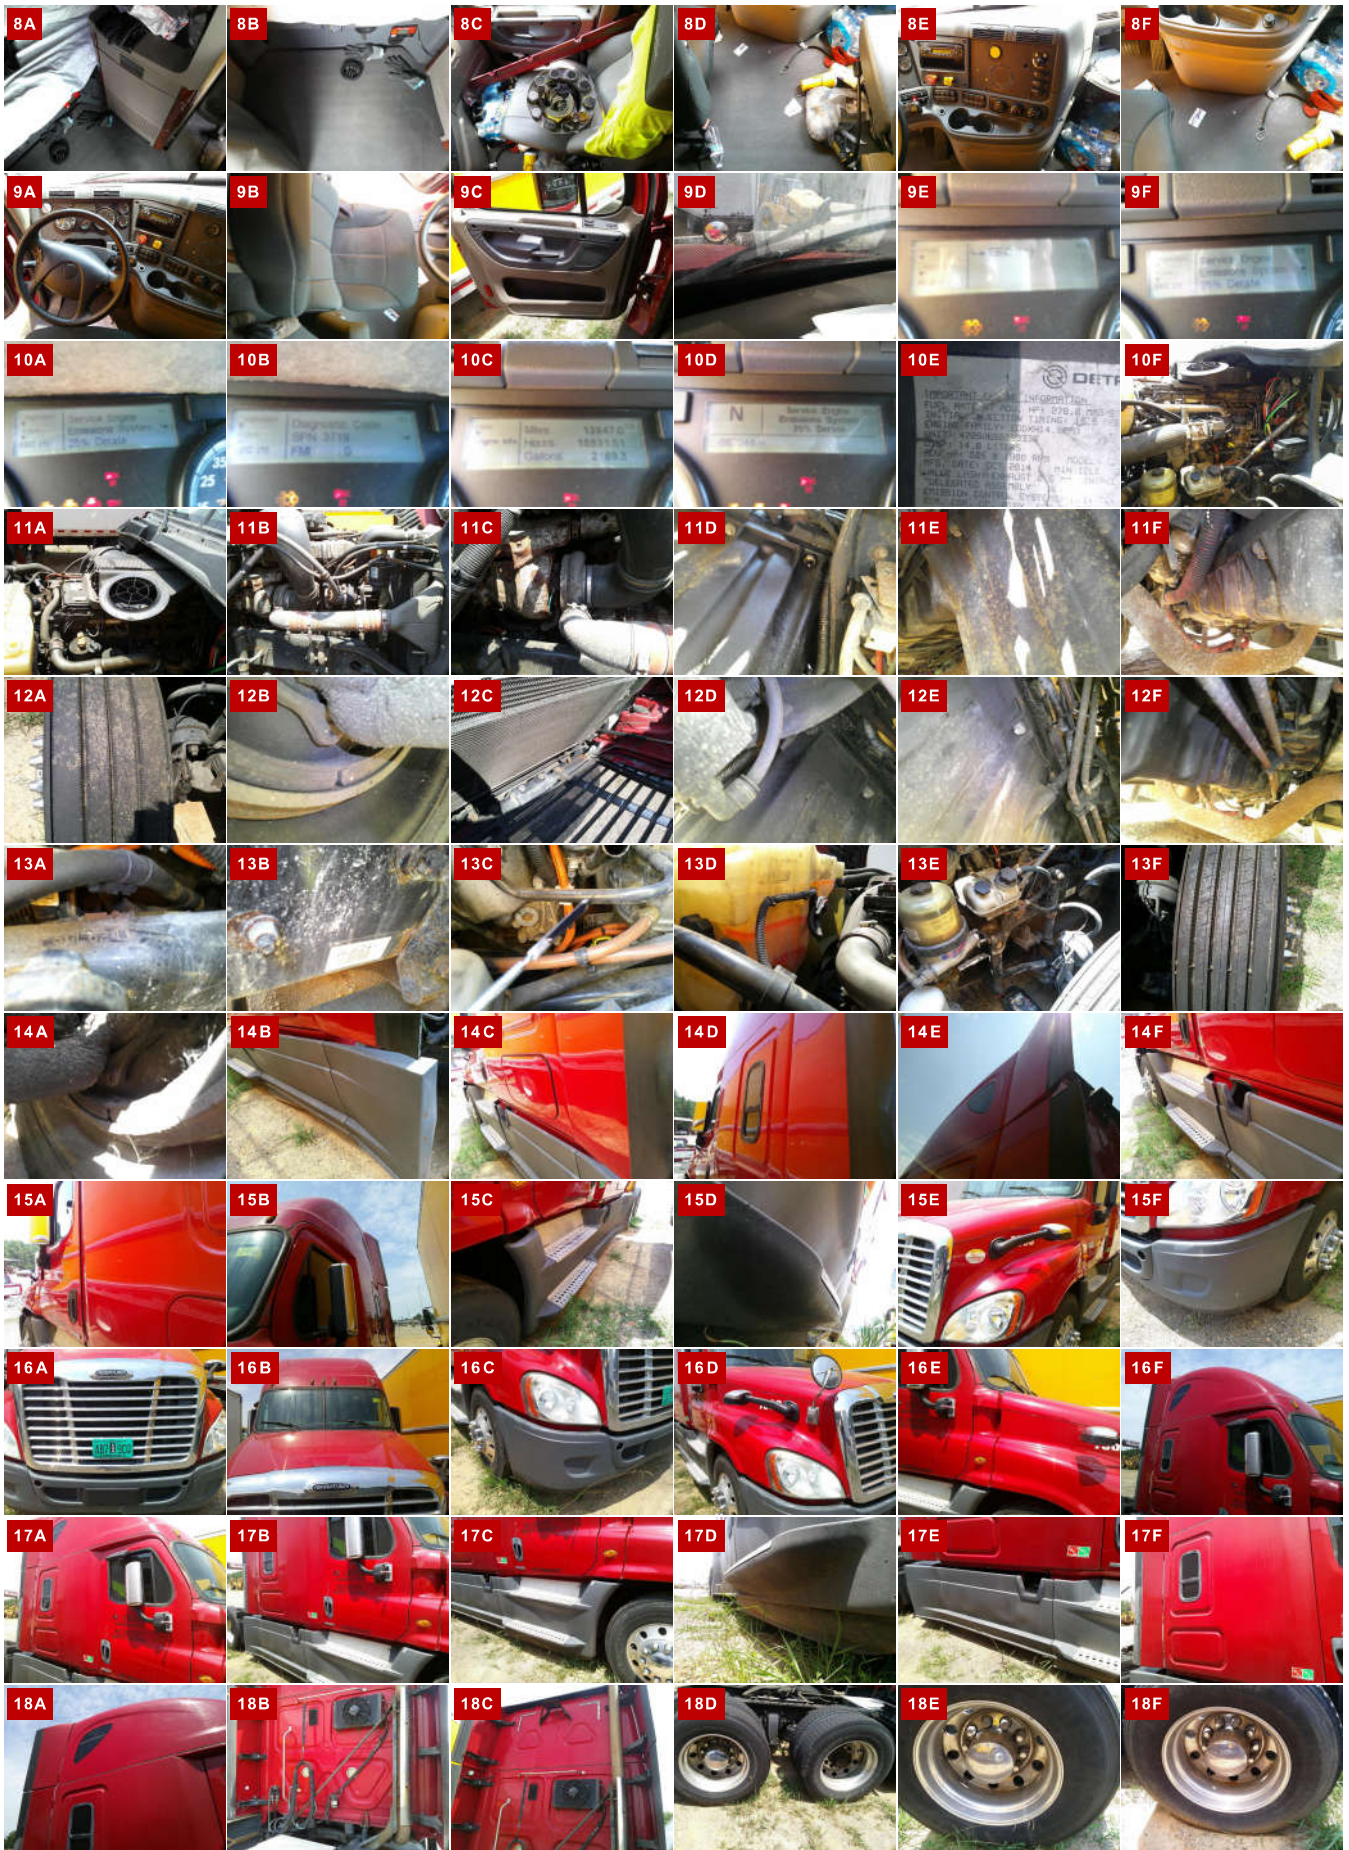
REPORT PHOTOS

ENGINE TURNED OVER BUT WOULD NOT START. APU NEEDS SERVICE. CHIPPED WINDSHIELD AT BOTTOM. UNIT TOWED TO FACILITY/ SEEPAGE AT BOTTOM OF BLOCK / OIL PAN.

WEAR & TEAR DETAIL	
DIAGNOSTICS	2 ACTIVE, 11 INACTIVE - SEE REPORT
INTERIOR	DIRTY
TIRES	7 BELOW 10/32'S
WHEELS	HUB COVER MISSING
FAIRINGS	MISSING RUBBER SKIRTS
BUMPER	SCUFFED / SCRATCHED
SLEEPER	CABINETS MISSING RIGHT SIDE, VARIOUS PARTS IN CAB
1/4 FENDERS	DAMAGED
MUD FLAP	LEFT SIDE MISSING
