**Commercial Credit Group, Inc (Mark Wenzel)**  
525 N Tryon Street, Charlotte, NC 28202 USA  
(704) 414-2456

VIN: 1HT MMMML2HH654774

**2017 INTERNATIONAL 4300**

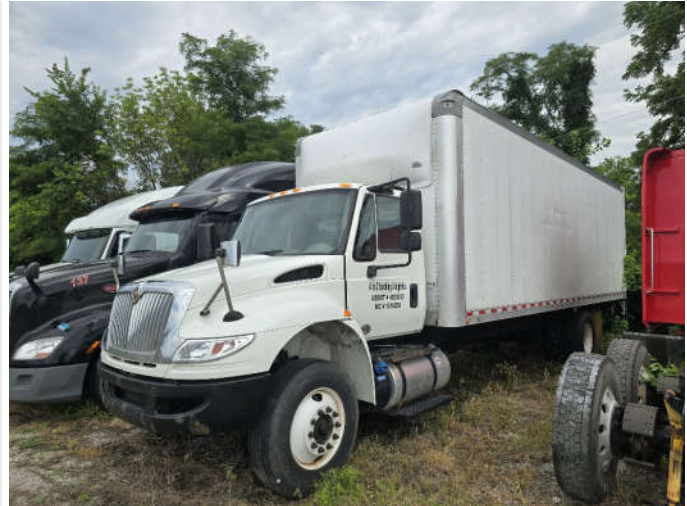
SPECIFICATIONS	
MILEAGE	331,970 / 334,972 (ECM)
ENGINE HOURS	31,783
ENGINE	CUMMINS ISB 6.7L 250 HP
ENG BRAKE	NO
ENG SERIAL	78949723
FUEL / TANKS	DIESEL - 1 ALUM 70 GAL TOTAL
TRANSMISSION	ALLISON 2500 HS 6 SPD AUTO
DRIVE OPTS	POWER STEERING, OVERDRIVE, CRUISE
REAR END	MERITOR 5.29
AXLE TYPE	SINGLE - F 10,000 LB / R 19,000 LB
GVWR	25,999
FRAME	STEEL
SUSPENSION	AIR RIDE
WHEELBASE	270"
TIRE SIZE	295/75R22.5
WHEELS	F STEEL / R STEEL
REAR D TYPE	ROLL-UP
LIFT GATE MAKE	MAXON
LIFT GATE CAPAC (LBS)	2500
INTERIOR H (IN)	97
EXTERIOR W (IN)	102
EXTERIOR L (FT)	26.0
AIR COND	YES, OPERATIONAL
INTERIOR COLOR	GRAY
HIGH BACK SEATS	DUAL
PASSENGER SEAT	STATIONARY
EXTERIOR COLOR	WHITE
BUMPER	PAINTED

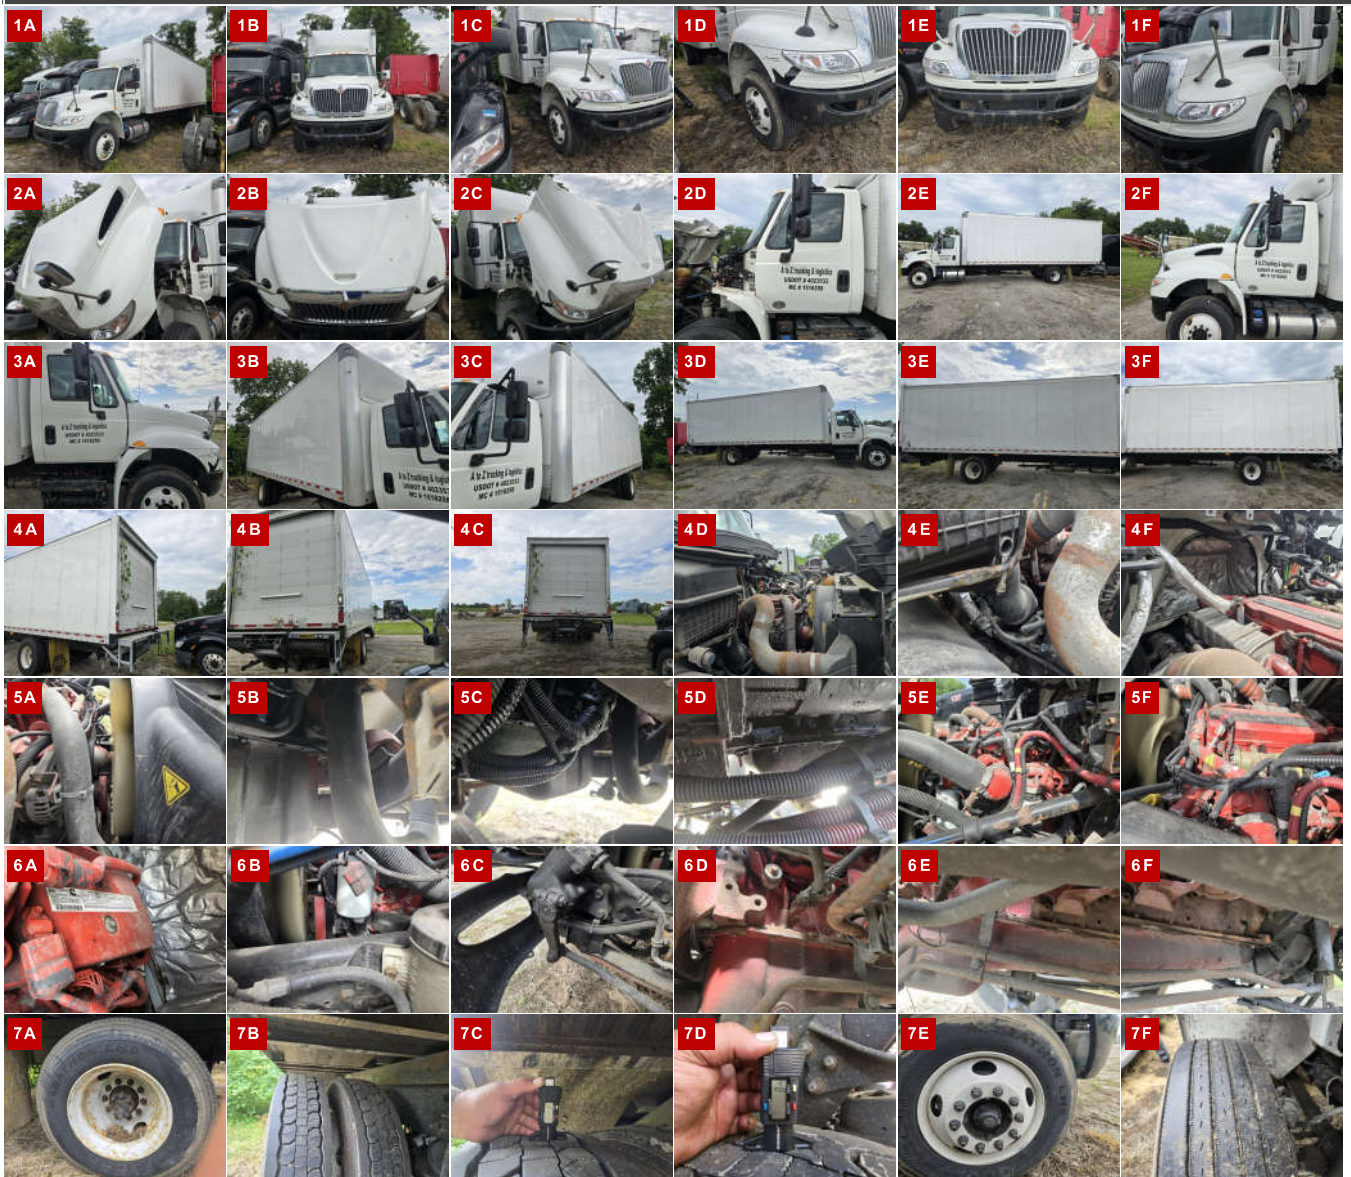
**REPORT PHOTOS**

ENGINE WOULD NOT REV HIGH ENOUGH TO SNAP TEST DPF. ENGINE DERATE IS ACTIVE. OIL LEAKING AT LOWER RIGHT SIDE OF ENGINE / OIL PAN AND AT REAR SEAL AREA.

<b>DIAGNOSTICS</b>	ENGINE, CAUTION, ABS AND TC LIGHTS ARE ON. 10 ACTIVE / 13 INACTIVE FAULTS DETECTED (SEE ECM REPORT)
<b>INTERIOR</b>	SURFACES AND UPHOLSTERY ARE DIRTY
<b>GAUGE</b>	OIL PRESSURE GAUGE NOT WORKING
<b>SEATS</b>	UPHOLSTERY WORN / STAINED ON BOTH SIDES, SMALL TEAR AT DRIVER SEAT
<b>FLOOR</b>	DRIVER SIDE MAT WORN THROUGH
<b>CAB ROOF</b>	MULTIPLE DENTS
<b>BOX</b>	SCRATCHES / DENTS AT WALL PANELING, FRONT LOWER RAIL DAMAGED AT BOTH ENDS, HOLES FORMING AT BOTTOM OF LEFT FRONT CORNER POST, UPPER REAR RAIL DENTED, LEFT AND RIGHT SIDE CRACKED BY THE TAILLIGHTS
<b>BUMPER</b>	SPOTS OF RUST FORMING
<b>HOOD</b>	CHIPPED AND RIGHT FENDER DAMAGED / BROKEN
<b>WINDSHIELD</b>	CHIPPED GLASS
<b>STEERING WHEEL</b>	SURFACES WORN AND HAS STICK RESIDUE
<b>ROLL DOOR</b>	DIFFICULT TO OPEN,
<b>BATTERIES</b>	CAN JUMP THE UNIT BUT WILL NOT TAKE A CHARGE
<b>DRIVE SHAFT</b>	DRIVE SHAFT UNMOUNTED FOR TOWING
