VIN: 3ALACWDT7HDHV4042

**2017 FREIGHTLINER M2**

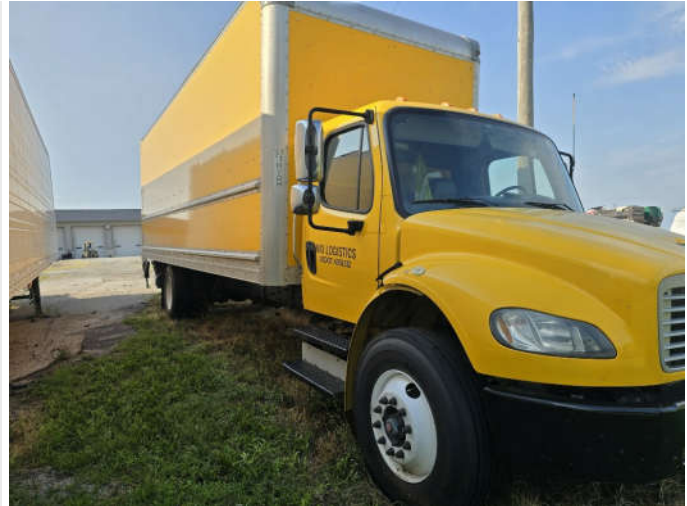
SPECIFICATIONS	
MILEAGE	183,398
ENGINE	CUMMINS 6.7 220 HP
ENG BRAKE	NO
ENG SERIAL	58650000
FUEL / TANKS	DIESEL - 1 ALUM 100 GAL TOTAL
TRANSMISSION	ALLISON 2200 RDS 6 SPD AUTO
DRIVE OPTS	POWER STEERING, OVERDRIVE, CRUISE
REAR END	DETROIT 5.56
AXLE TYPE	SINGLE - F 10,000 LB / R 19,000 LB
GVWR	26,000
FRAME	STEEL
SUSPENSION	AIR RIDE
WHEELBASE	270"
TIRE SIZE	11R22.5
WHEELS	F STEEL / R STEEL
REAR D TYPE	ROLL-UP
LIFT GATE MAKE	WALTCO
LIFT GATE MODEL	HL F40
LIFT GATE CAPAC (LBS)	3000
INTERIOR H (IN)	103
EXTERIOR W (IN)	102
EXTERIOR L (FT)	26.0
AIR COND	YES
INTERIOR COLOR	GRAY
HIGH BACK SEATS	DRIVER SIDE ONLY
PASSENGER SEAT	STATIONARY
EXTERIOR COLOR	YELLOW
BUMPER	PAINTED
EXTERIOR OPTS	HEATED MIRRORS
