Commercial Credit Group, Inc (Mark Wenzel)  
525 N Tryon Street, Charlotte, NC 28202 USA  
(704) 414-2456

VIN: 4V4NC9EHXJN904270

2018 VOLVO VNL64

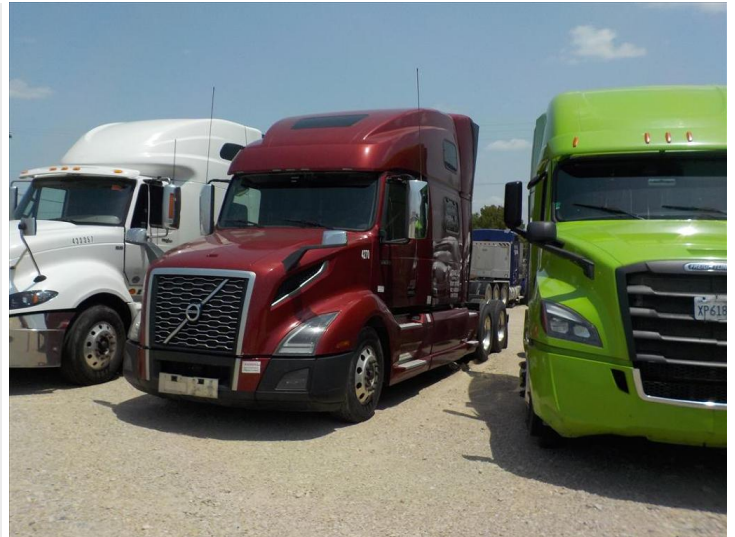
SPECIFICATIONS	
ENGINE	VOLVO D13 12.8L 425 HP
ENG SERIAL	1192596
FUEL / TANKS	DIESEL - 2 ALUM 200 GAL TOTAL
EXHAUST	HORIZONTAL
TRANSMISSION	VOLVO ATO-2612F 12 SPD AUTO
DRIVE OPTS	POWER STEERING, OVERDRIVE, CRUISE
REAR END	MERITOR 2.64
AXLE TYPE	TANDEM - F 13,200 LB / R 38,000 LB
GVWR	51,200
FRAME	STEEL
SUSPENSION	AIR RIDE
TIRE SIZE	295 75R 22.5
WHEELS	F ALUMINUM / R ALUMINUM
WHEEL 5TH	AIR SLIDE
AIR COND	YES
AUX POWER UNIT?	NO
SLEEPER	77"
DUAL BUNK	YES
INTERIOR COLOR	TAN/GRAY
RADIO	AM/FM, OPERATIONAL
MIRRORS	DUAL POWER
HIGH BACK SEATS	DUAL
PASSENGER SEAT	AIR RIDE
EXTERIOR COLOR	RED
BUMPER	PAINTED
EXTERIOR OPTS	HEATED MIRRORS, FULL FAIRINGS
