Commercial Credit Group, Inc (Mark Wenzel)
525 N Tryon Street, Charlotte, NC 28202 USA
(704) 414-2456

VIN: 1HTMMMML4KH514846
PO #: 15045

2019 INTERNATIONAL 4300

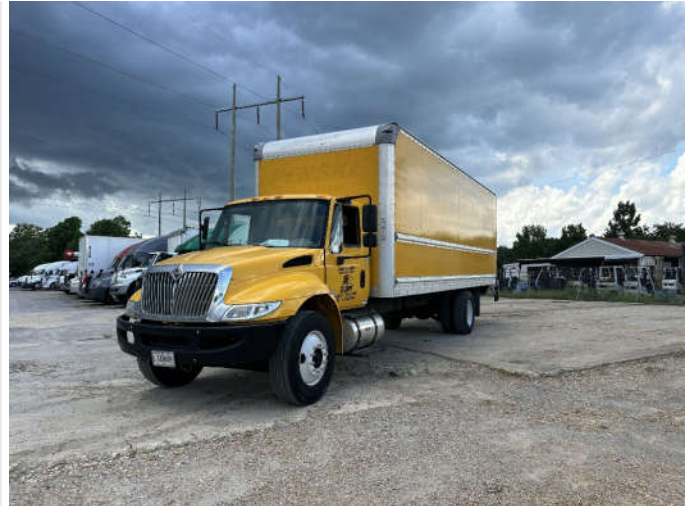
BRAKES	
LEFT FRONT	RIGHT FRONT
COVERED	COVERED
LEFT REAR 1	RIGHT REAR 1
COVERED	COVERED

ADDITIONAL BRAKE DETAIL
ALL BRAKES SHIELDED
