INSPECTION REPORT

Report #34683 07/23/2024

COMMERCIAL CREDIT GROUP, INC

2023 KAUFMAN MINI V DOUBLE DECK

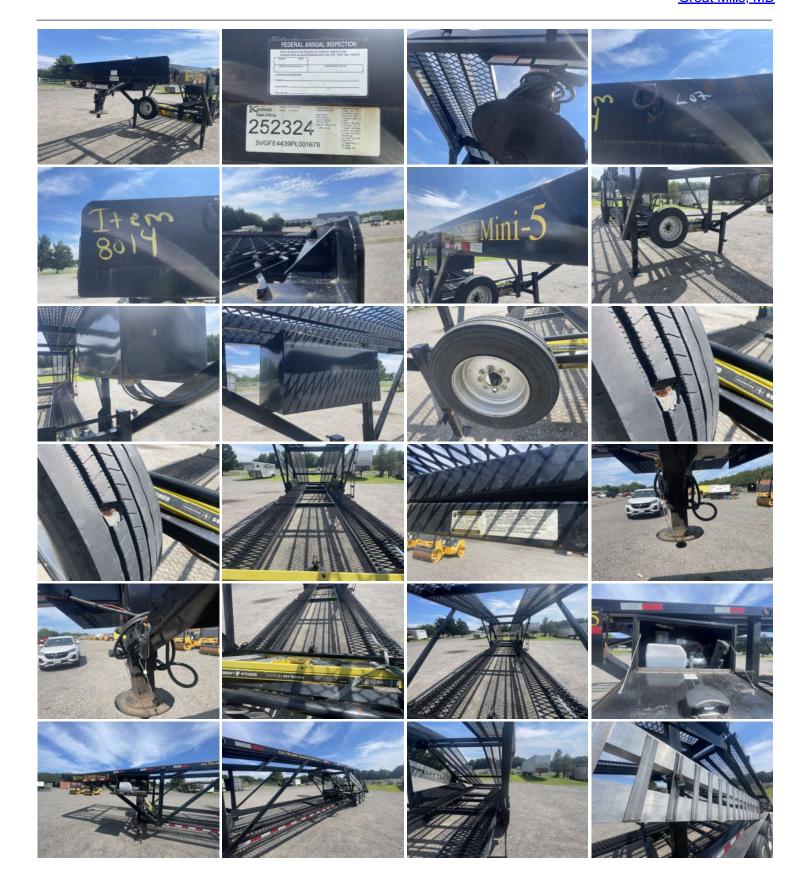
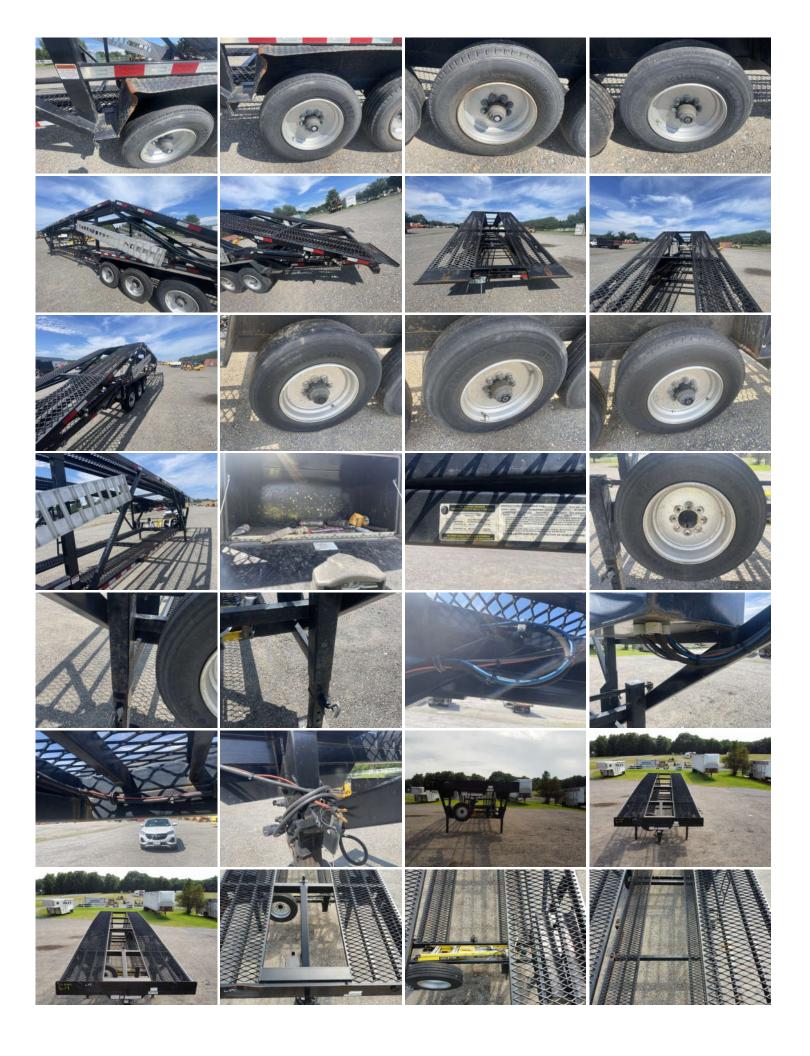
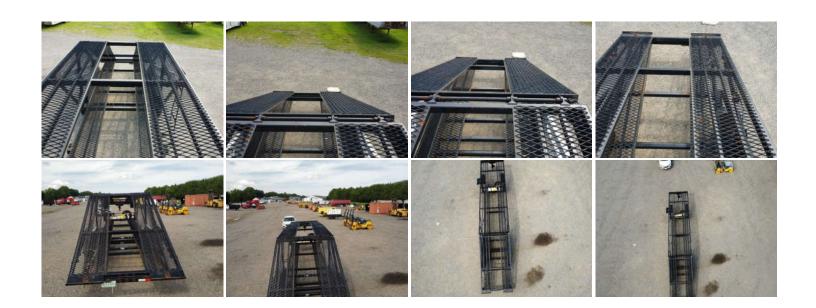
The unit Overall is in great condition. Not much rust, not straps or tie downs observed. The Sailun tires are in great condition as well. The length is 44'10". Height 94" lower deck 80" usable. 8" tool box on both sides. The spare tire I severely damaged. The unit has a couple small dings or slight bends.
