National Inspection Services

Report: 269362 07/17/2024

VIN: 1UYVS2539FM115407

2015 UTILITY VS2RA

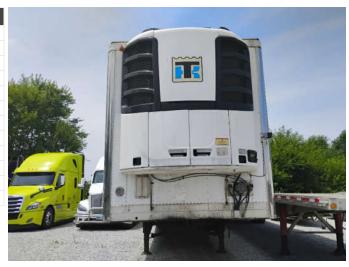
SPECIFICATIONS	
AXLE TYPE	TANDEM - F 20,000 LB / R 20,000 LB	
SPREAD AXLE	NO	
FRAME	STEEL	
SUSPENSION	AIR RIDE	
TIRE SIZE	275/80R22.5	
WHEELS	F ALUMINUM / R ALUMINUM	
REEFER TYPE	DIESEL	
REEFER MAKE	THERMOKING	
REEFER MODEL	SR4	
REAR D TYPE	SWING	
EXTERIOR L (FT)	53.0	
EXTERIOR COLOR	WHITE

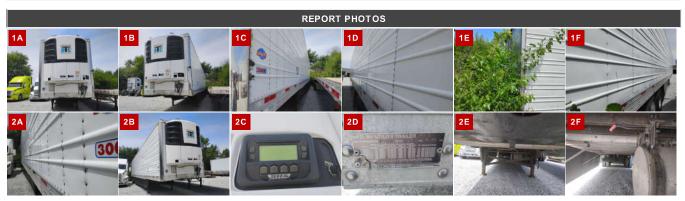
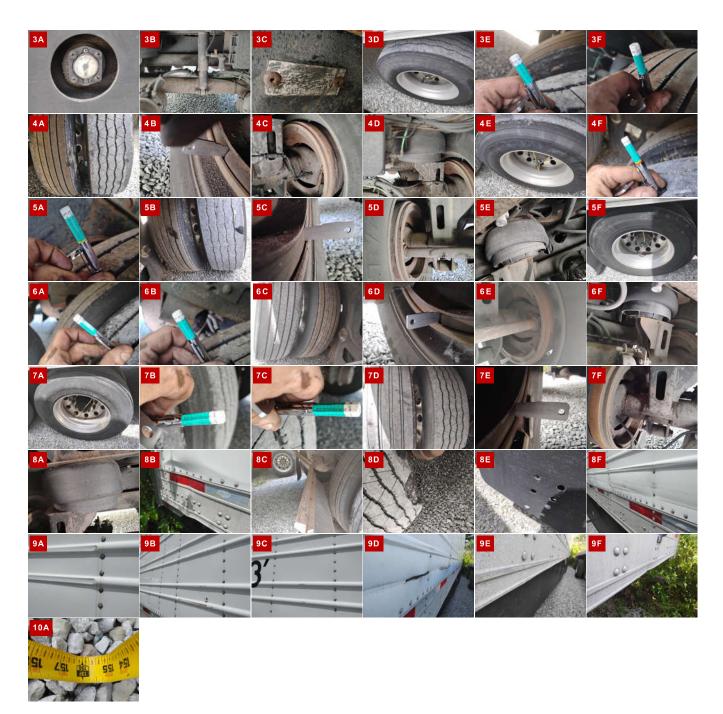
REEFER WOULDN'T START. WEEDS AND TREES COVERED THE REAR DOORS.

WEAR & TEAR DETAIL			
TIRES	8 TIRES LESS THAN 10/32		
EXTERIOR BOX	SCRATCHES DOWN BOTH SIDES. D/S BOTTOM RAIL IS BENT TOWARDS THE REAR. P/S REAR CORNER IS BENT.		
MUD FLAP	MUD FLAP HANGER BENT.		
FAIRING	D/S LOWER FAIRING IS LOOSE, HAS BEEN REMOUNTED.
