Commercial Credit Group, Inc (Mark Wenzel)
525 N Tryon Street, Charlotte, NC 28202 USA
(704) 414-2456

VIN: 3HSDZAPR5JN249640

2018 INTERNATIONAL LT625

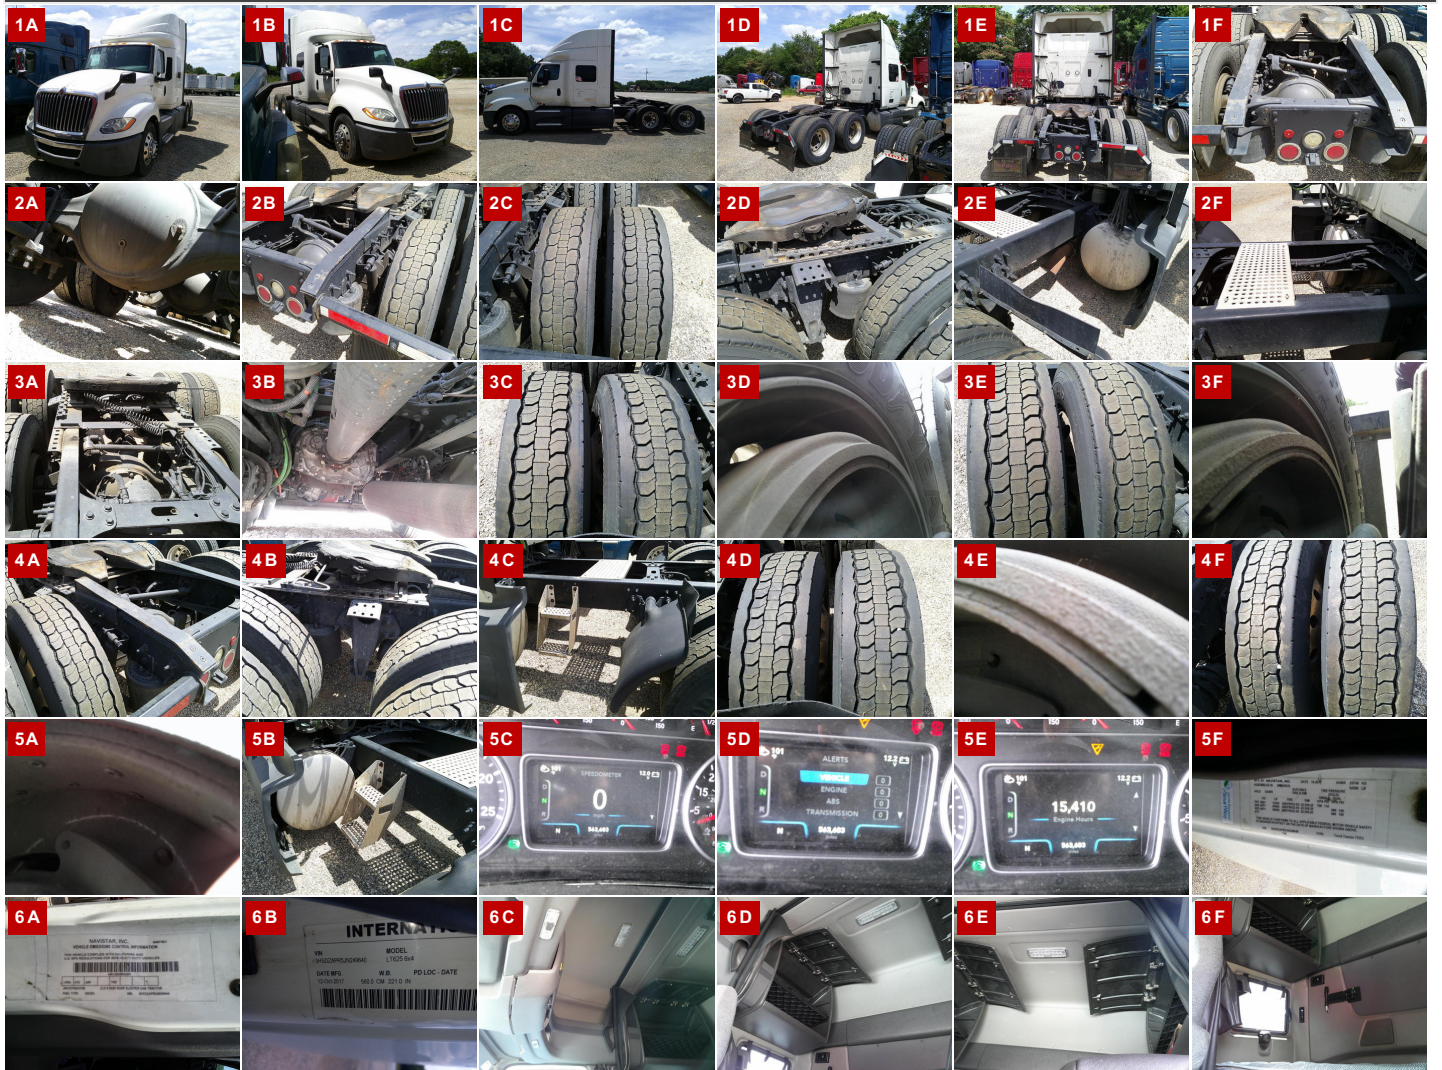
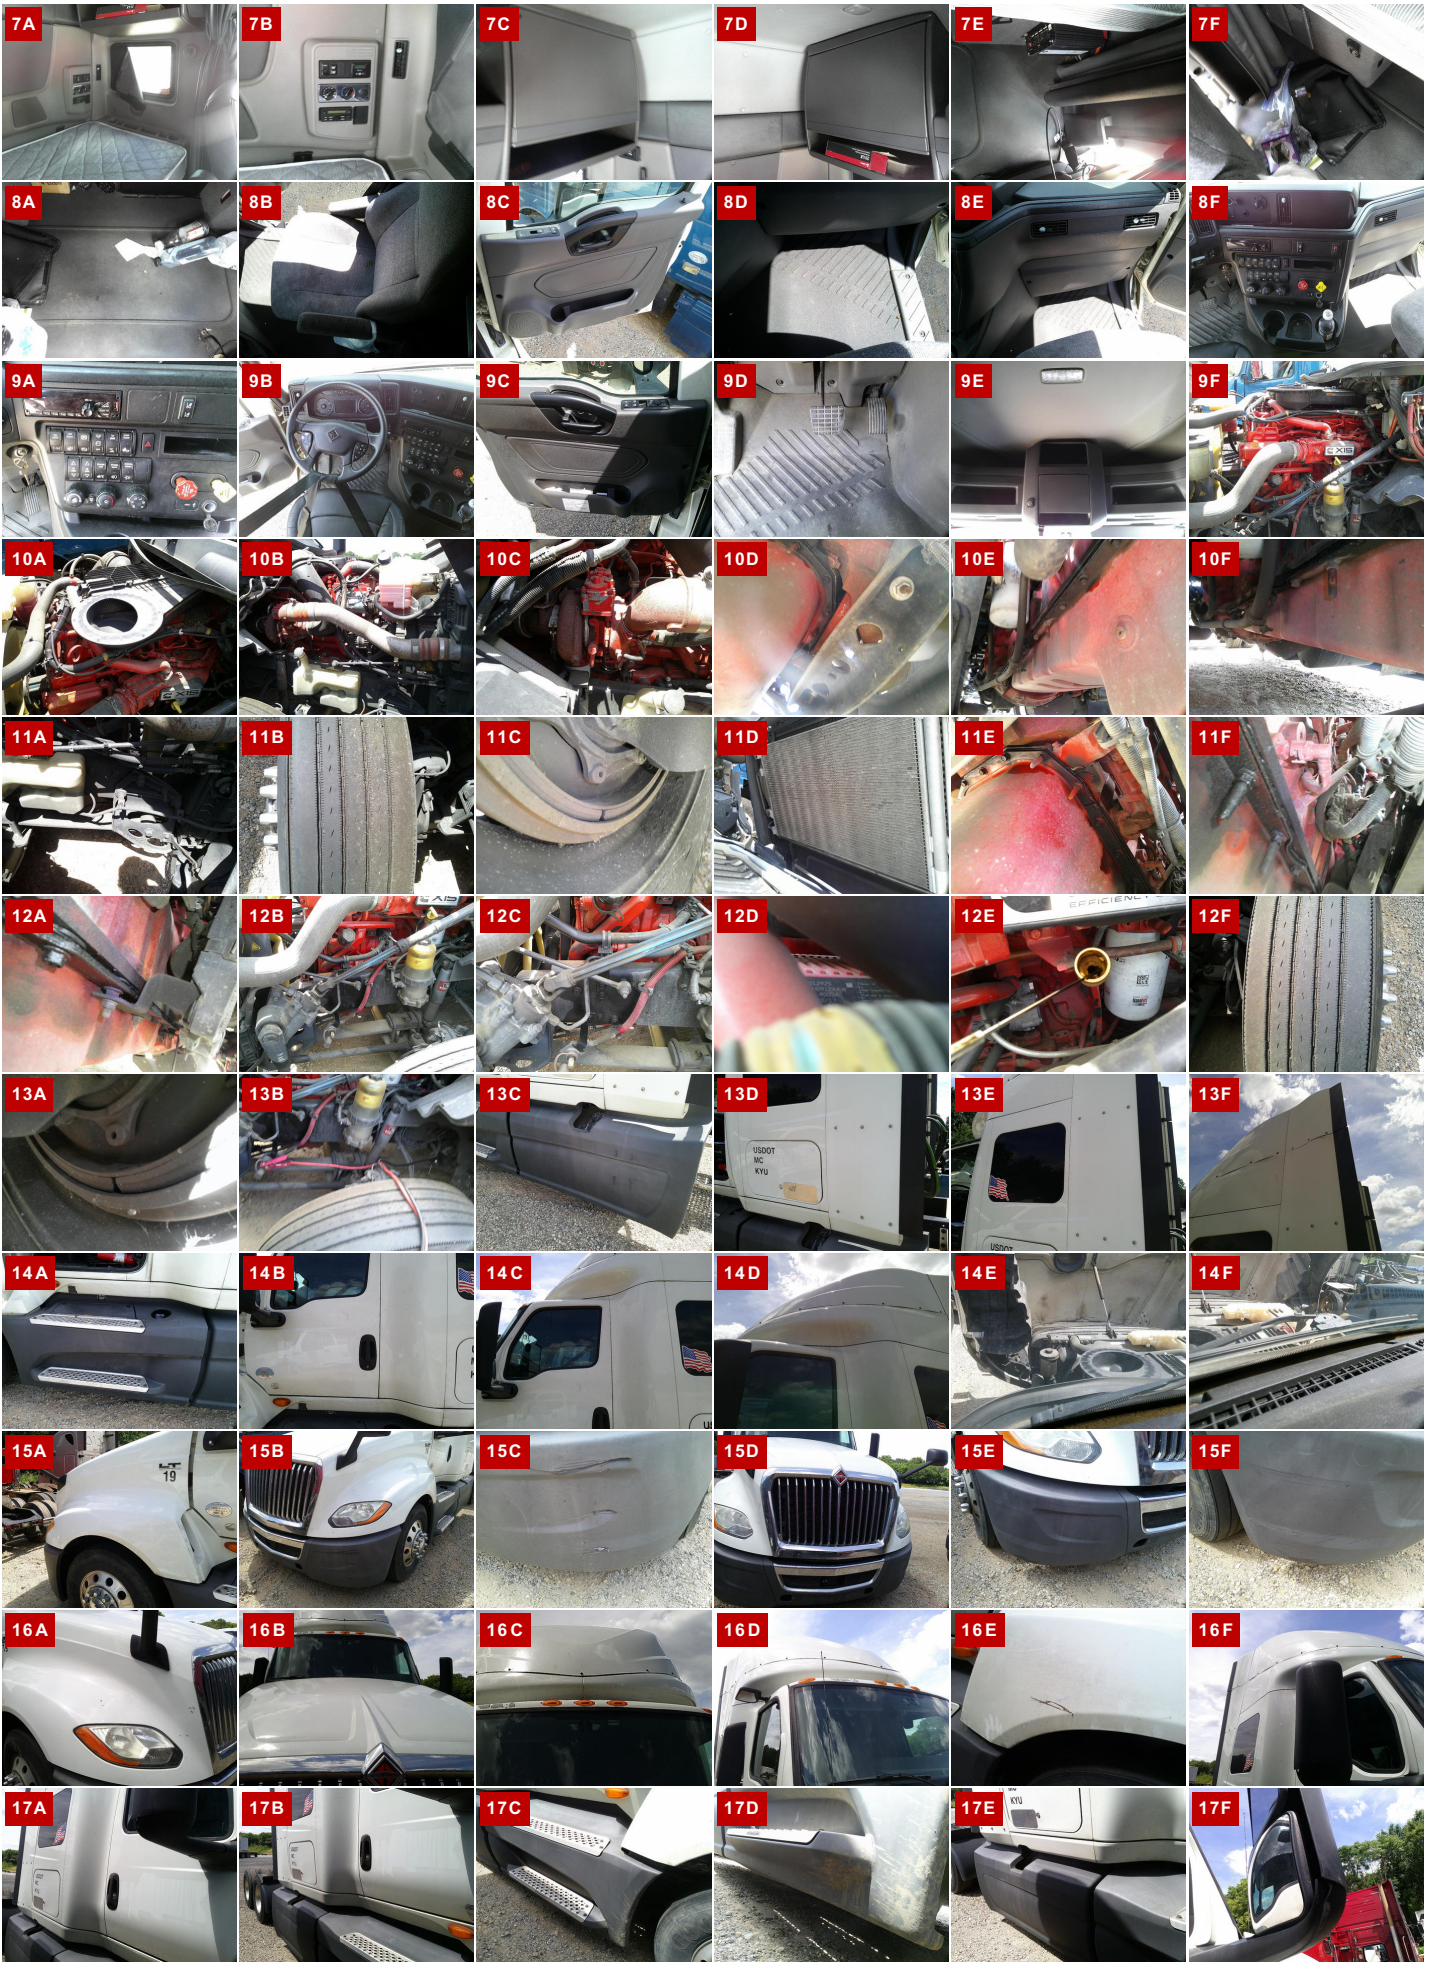
REPORT PHOTOS

UNIT TOWED TO LOCATION. BATTERIES WEAK. LIMITED ELECTRICAL OPERATION. UNABLE TO START ENGINE OR TEST ALL SYSTEMS. OIL LEAKAGE ALONG OIL PAN GASKET.

DIAGNOSTICS	4 ACTIVE / 15 INACTIVE FAULTS DETECTED (SEE ECM REPORT)
BUMPER	RIGHT SIDE SCRATCHED, LEFT SIDE SCRAPED / GOUGED
ROOF	PAINT PEELING
HOOD / FENDERS	LARGE SCRATCH ON LEFT SIDE, PAINT CHIPS AT FRONT
TANK FAIRING	LEFT SIDE SCRAPED
ANTENNA	MISSING AT LEFT SIDE OF CAB
LIGHTS	LOW HEADLIGHT BEAM AND MARKER LIGHT INOP
DOOR MIRROR	RIGHT SIDE HOUSING CRACKED
INTERIOR	SURFACES AND UPHOLSTERY ARE DIRTY
POWER STEERING	RESERVOIR HOSE LEAKING
WINDSHIELD	GLASS CHIPPED
SEATS	UPHOLSTERY WORN / STAINED
BRAKES	LININGS WORN THIN AT REAR AXLES
