VIN: 1FVACXDT6GHGW5481

2016 FREIGHTLINER M2 106

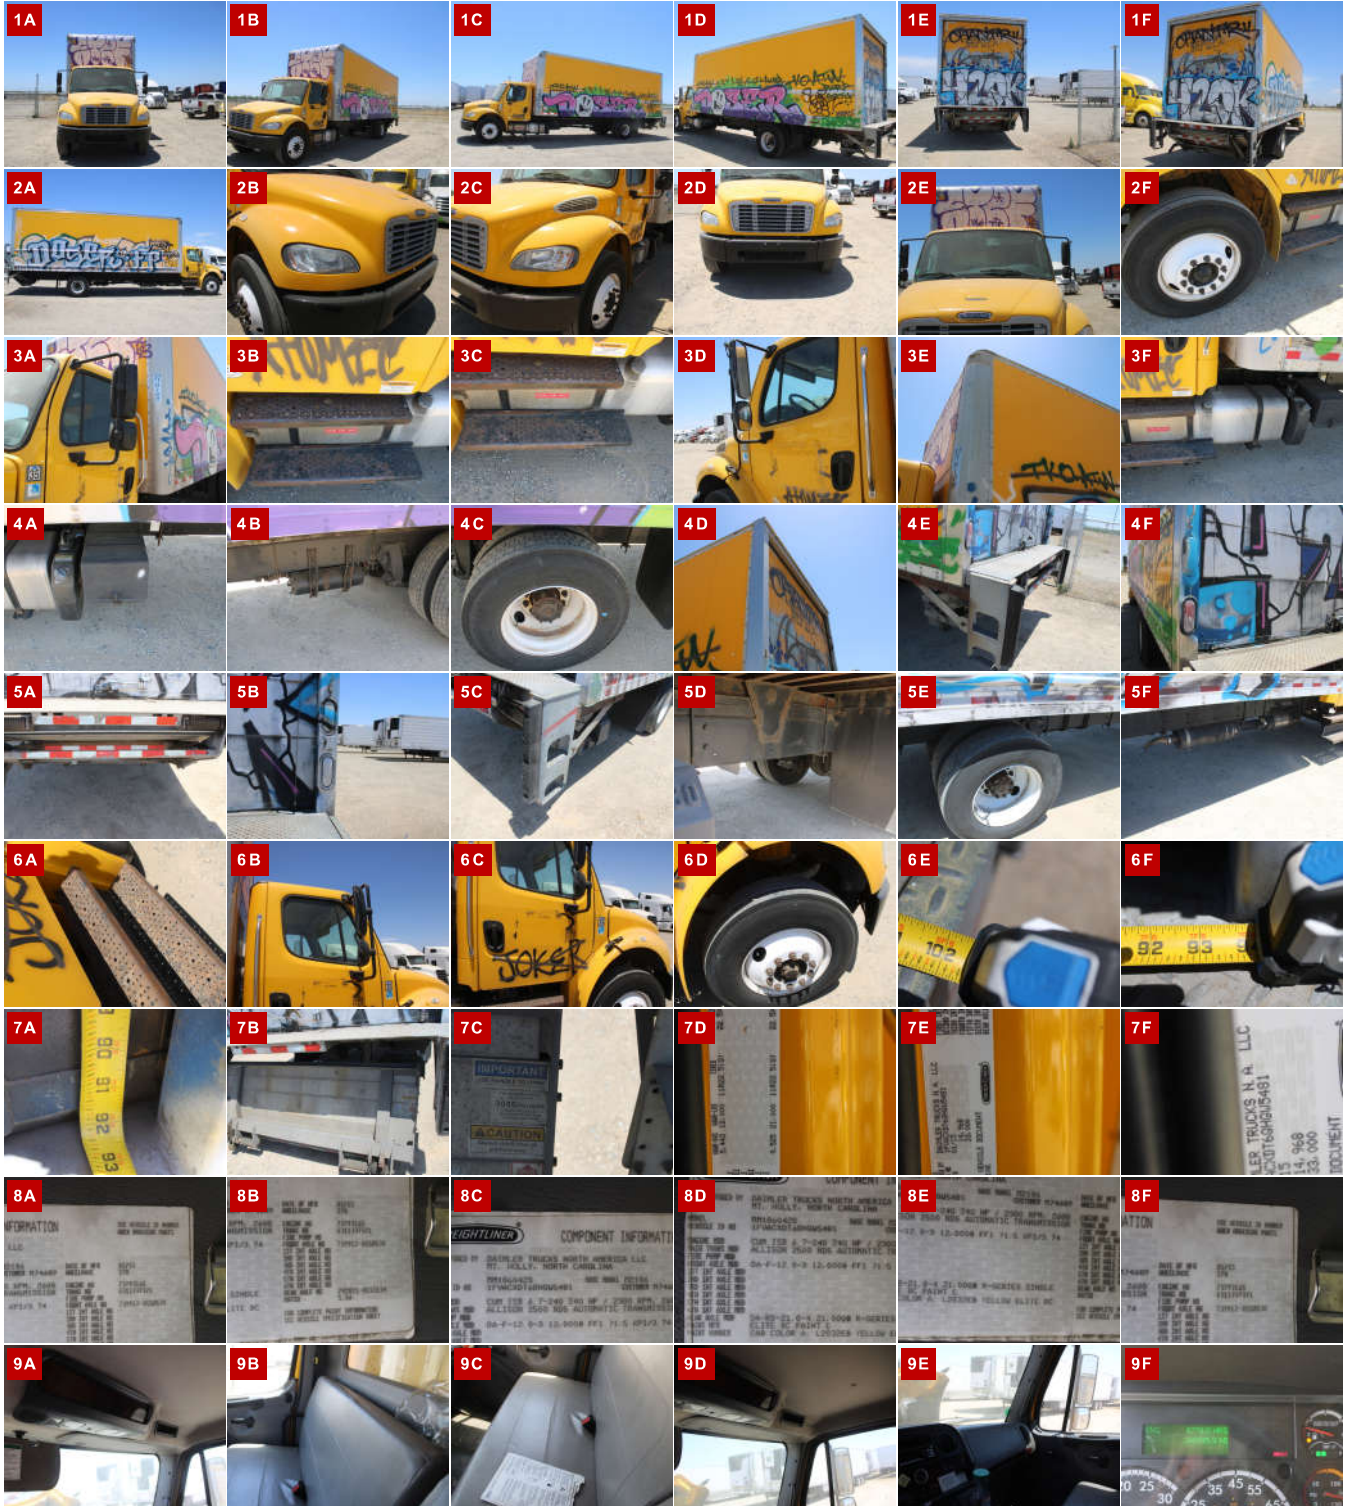
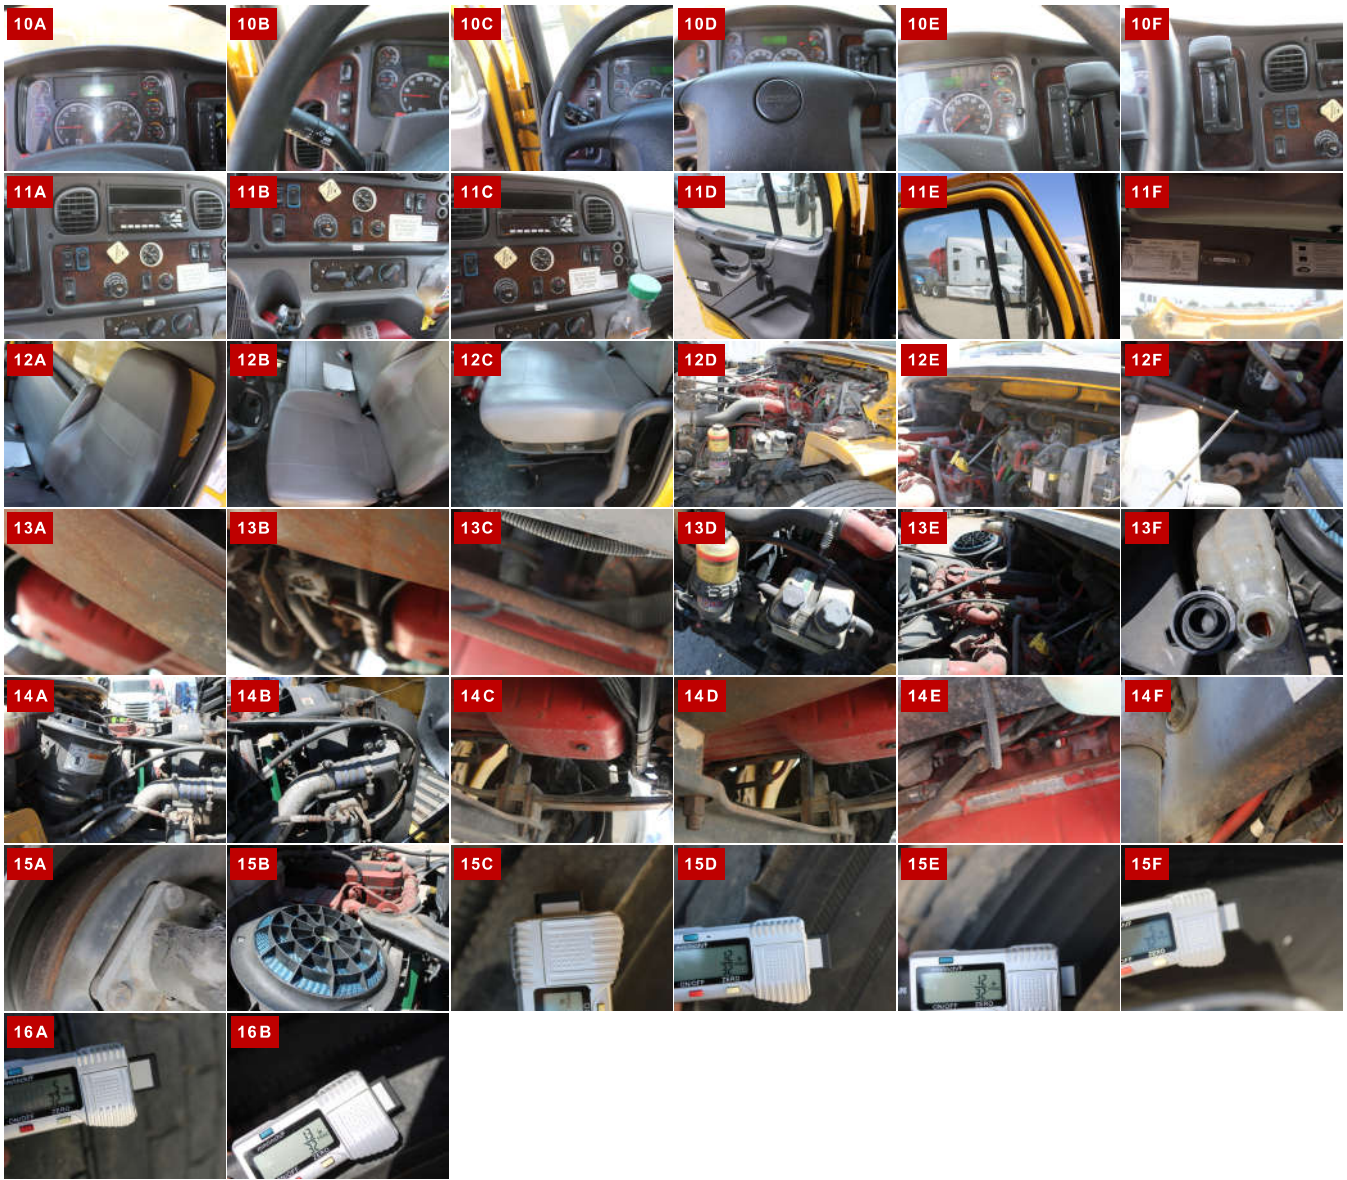
REPORT PHOTOS

DIAGNOSTICS	22 INACTIVE FAULTS DETECTED (SEE ECM REPORT)
CAB STEPS	PAINT WORN AND RUST FORMING AT BOTH SIDES
REAR DOOR	DOOR JAMMED, UNABLE TO OPEN
EXTERIOR	ALL SIDES OF BOX AND BOTH SIDES OF CAB COVERED W/ GRAFFITI
HEADLINER	STARTING TO COME LOOSE IN SPOTS
STEERING WHEEL	WORN AND DAMAGED, COVER TORN
TIRES	2 MEASURE BELOW 10/32
