**Commercial Credit Group, Inc (Mark Wenzel)**  
525 N Tryon Street, Charlotte, NC 28202 USA  
(704) 414-2456

VIN: 3AKJGED50GDHJ3206

**2016 FREIGHTLINER CASCADIA 125**

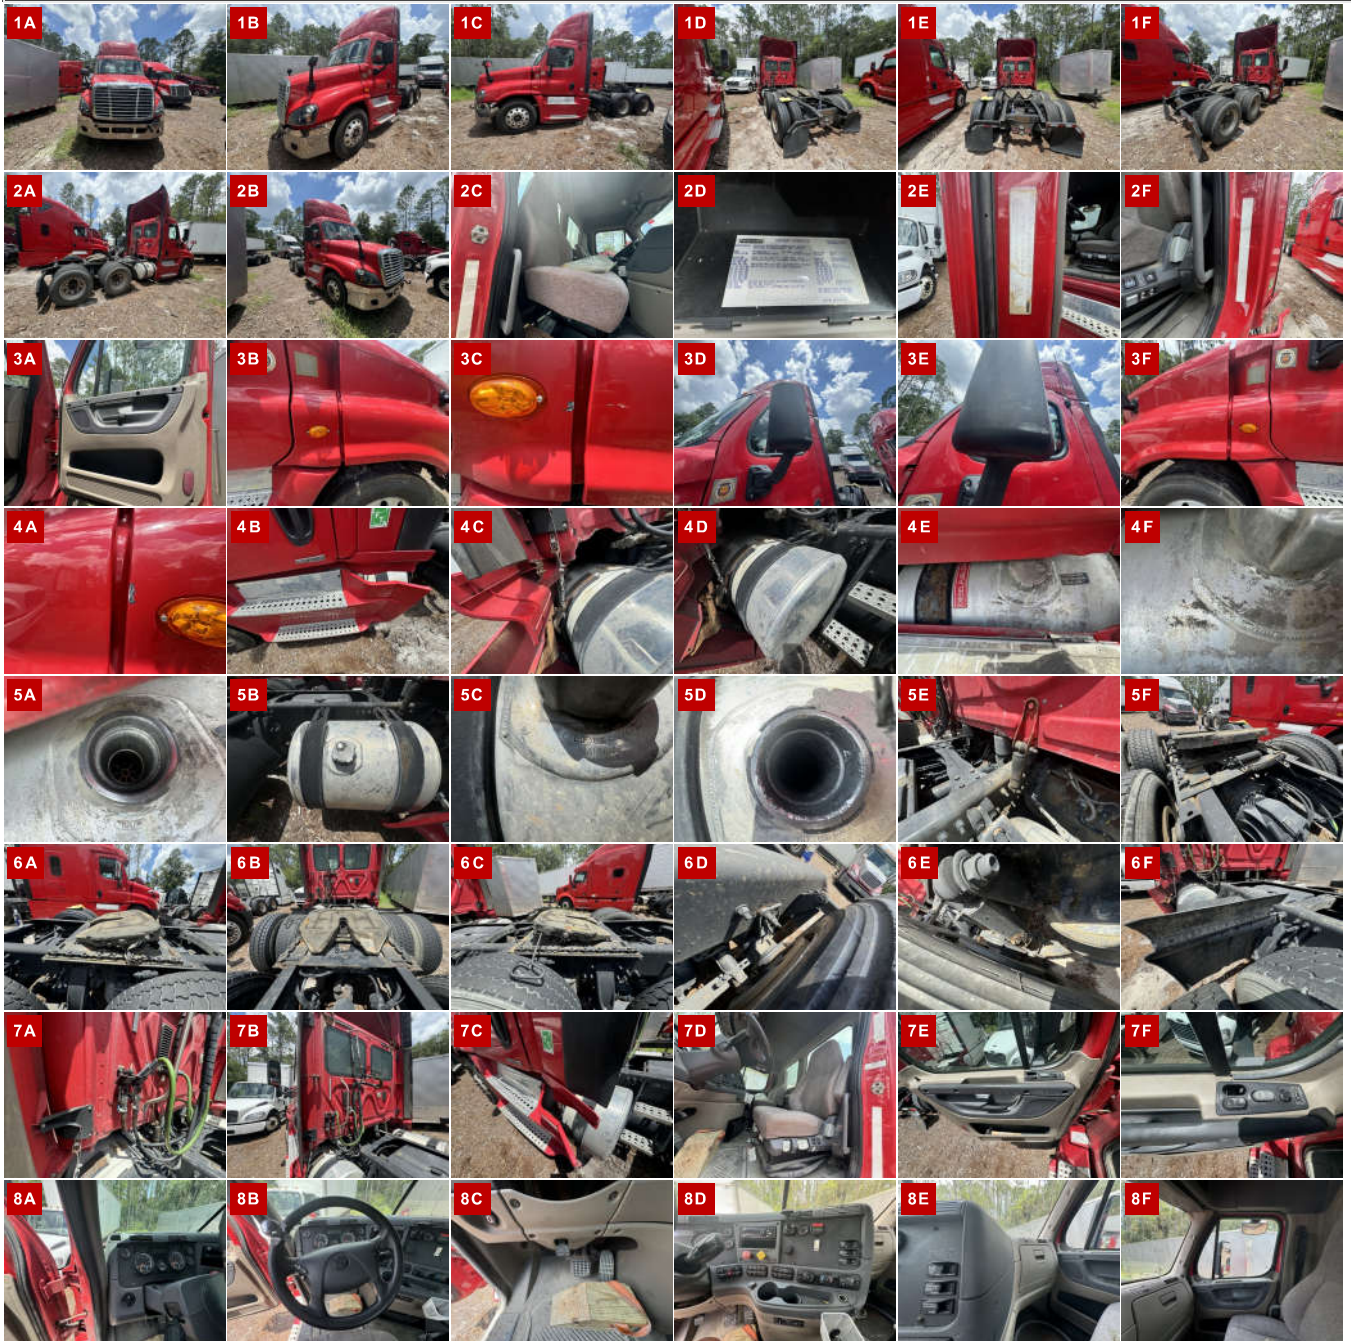
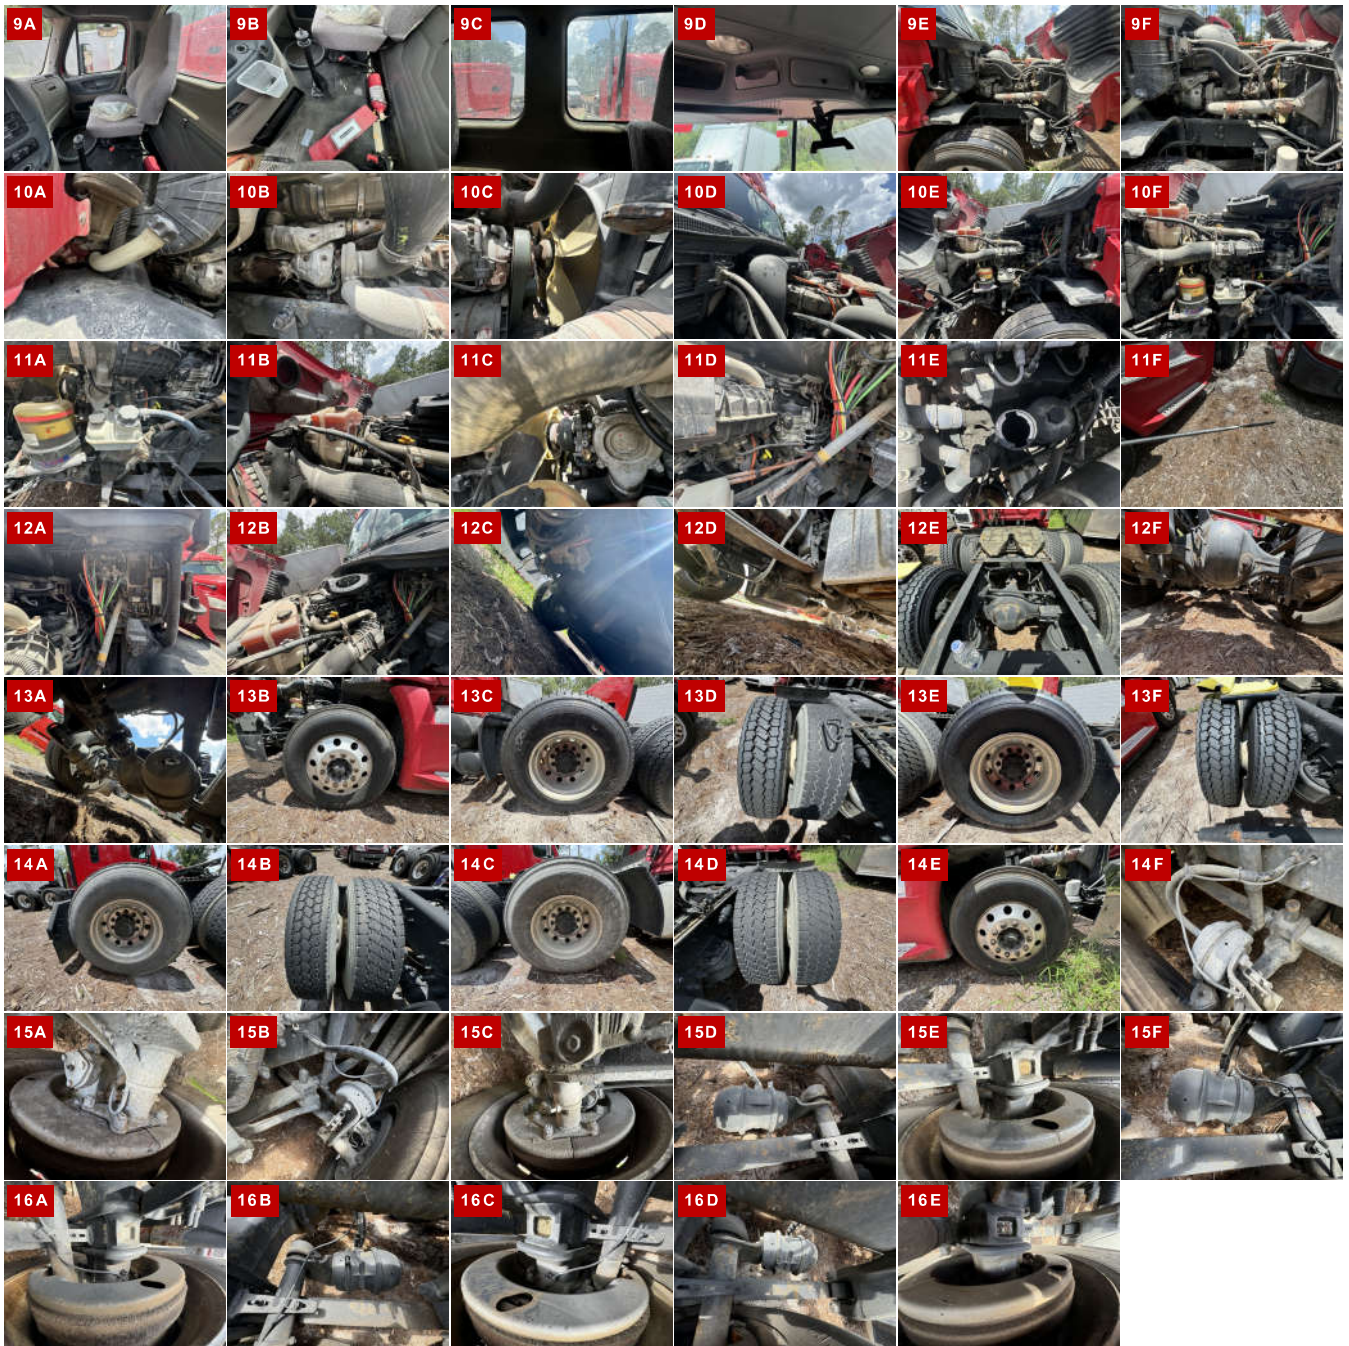
**REPORT PHOTOS**

ENGINE OIL LEAK AT THE REAR OF THE OIL PAN

<b>DIAGNOSTICS</b>	NO KEY COULD NOT RUN OR ALL CHECK FUNCTIONS
<b>MIRROR</b>	SIDE MIRROR SCRATCHED ON DRIVER SIDE
<b>DOOR</b>	WINDOW BUTTON MISSING FROM DRIVER DOOR. SCRAPED ON THE P/S
<b>COWL</b>	CHIPPED ON P/S
<b>CAB</b>	REAR OF CAB SCUFFED FROM AIR HOSES AND PAINT IS PEELING ON D/S. RUST STAINING ON REAR OF CAB
<b>STEERING WHEEL</b>	SURFACES HAVE WEAR
<b>DASH</b>	ADHESIVE RESIDUE IN THE CENTER OF THE DASH
<b>FUEL TANKS</b>	STRAP MISSING ON D/S
<b>SEATS</b>	BOTH ARE SHOWING WEAR
<b>TIRES</b>	5 TIRES BELOW 10/32.
