National Inspection Services

Report: 270335 07/31/2024

VIN: 1FVACXCY7EHFP0647

2014 FREIGHTLINER M2

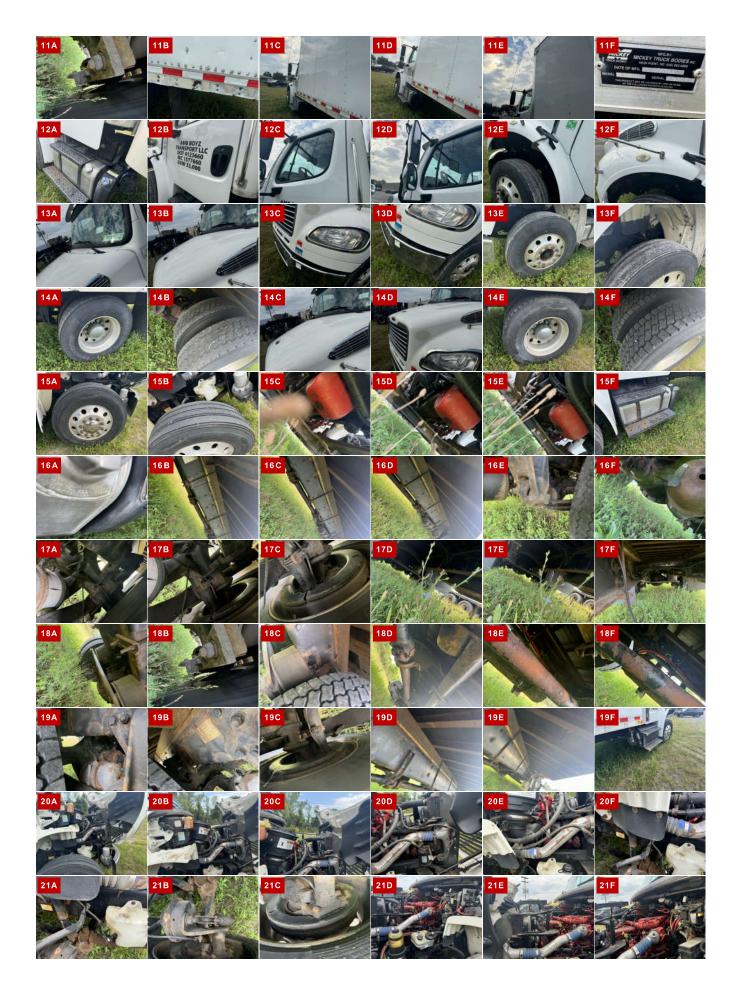
DIAGNUSTIC	TACTIVE FAULT / I/ INACTIVE FAULTS FOUND - (SEE ECWI REPORT)
KEYS	MISSING
CORROSION	PRESENT ON LOWER ALUMINUM RAIL ON VAN BOX
CHASSIS, SUSPENSION AND AXLES.	RUST IN VARIOUS LOCATIONS.
TIRES	2 TIRES WORN BELOW 10/32.
