VIN: 3HSDJSNR2HN447862
PO #: 15110

2017 INTERNATIONAL PROSTAR 122

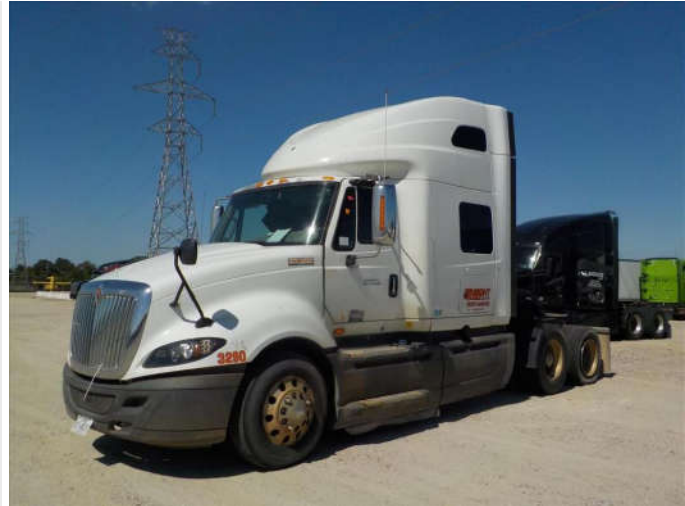
SPECIFICATIONS	
MILEAGE	542,861 / 542,845 (ECM)
ENGINE HOURS	19,395
ENGINE	NAVISTAR N13 12.4L 450 HP
ENG BRAKE	YES
ENG SERIAL	2Y4412096
FUEL / TANKS	DIESEL - 2 ALUM 200 GAL TOTAL
EXHAUST	HORIZONTAL
TRANSMISSION	EATON FAOM-15810S-EN3 10 SPD AUTO
DRIVE OPTS	POWER STEERING, OVERDRIVE, CRUISE
REAR END	MERITOR 2.64
AXLE TYPE	TANDEM - F 12,350 LB / R 40,000 LB
GVWR	52,350
FRAME	STEEL
SUSPENSION	AIR RIDE
WHEELBASE	226"
TIRE SIZE	F 295 75R 22.5 / R 445 50R 22.5
WHEELS	F ALUMINUM / R ALUMINUM
WHEEL 5TH	AIR SLIDE
AIR COND	YES, OPERATIONAL
SLEEPER	72"
DUAL BUNK	YES
INTERIOR COLOR	GRAY
RADIO	AM/FM / CD, OPERATIONAL
MIRRORS	DUAL POWER
HIGH BACK SEATS	DUAL
PASSENGER SEAT	AIR RIDE
EXTERIOR COLOR	WHITE
BUMPER	PAINTED
EXTERIOR OPTS	HEATED MIRRORS, FULL FAIRINGS

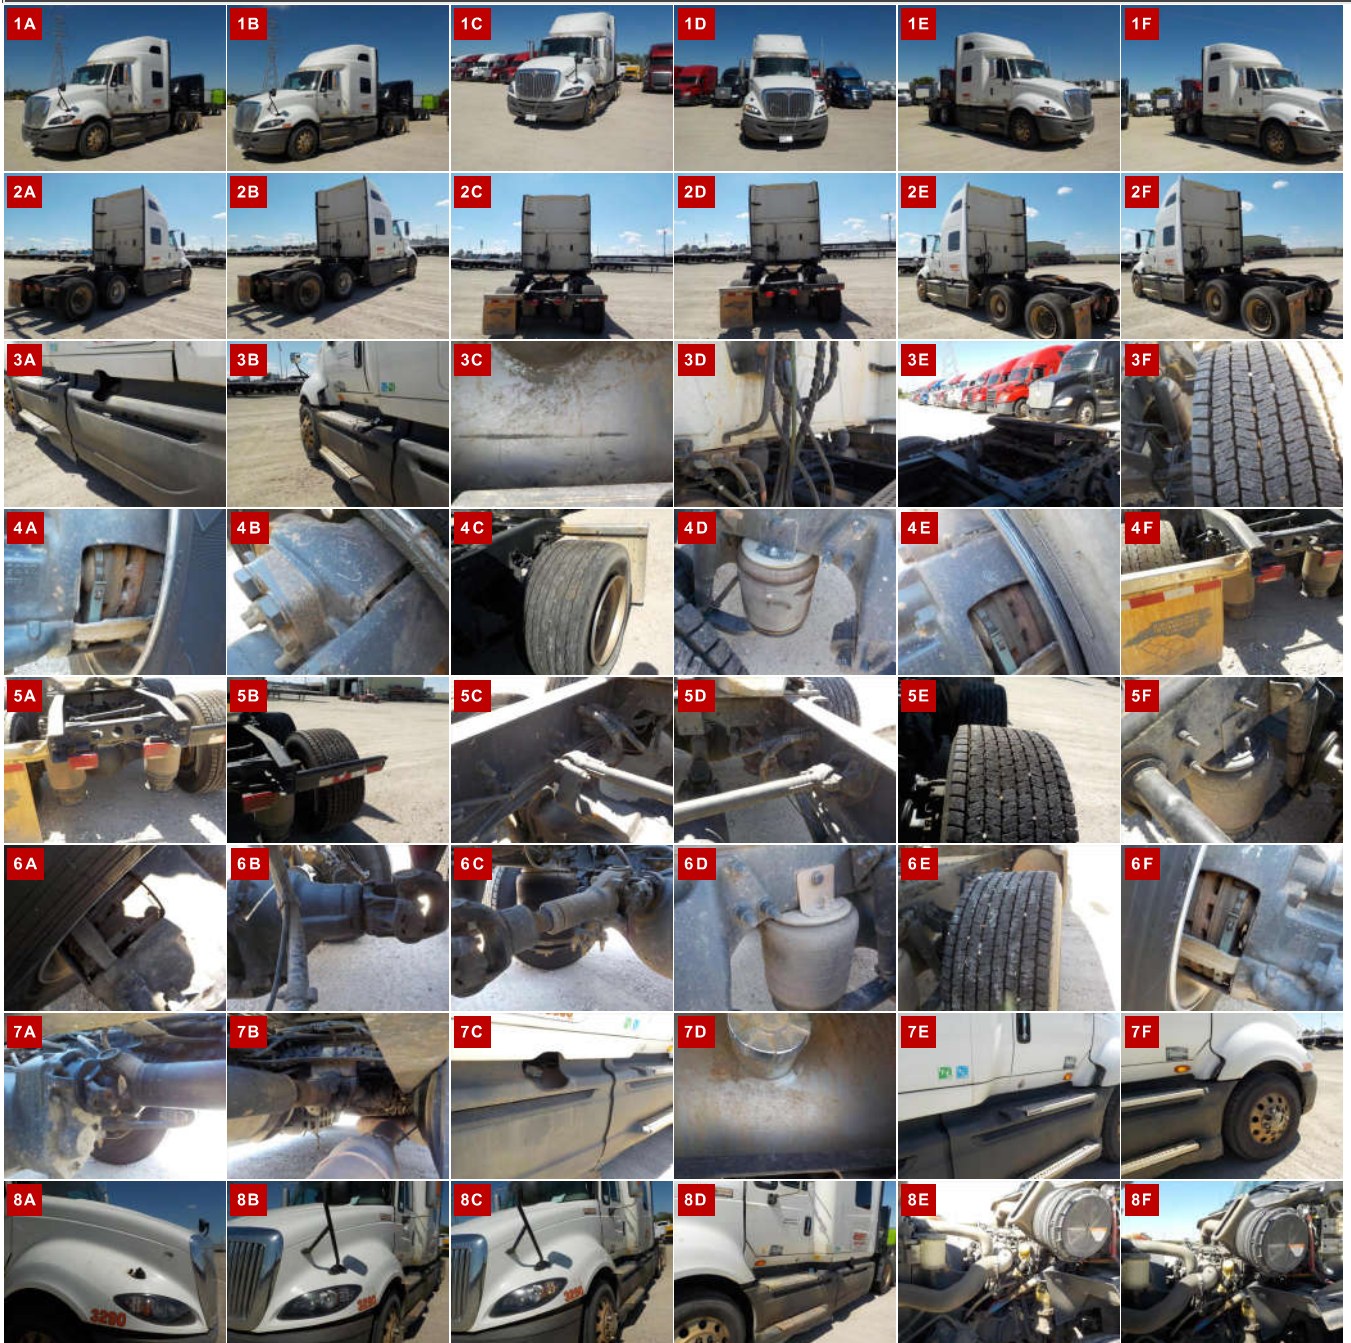
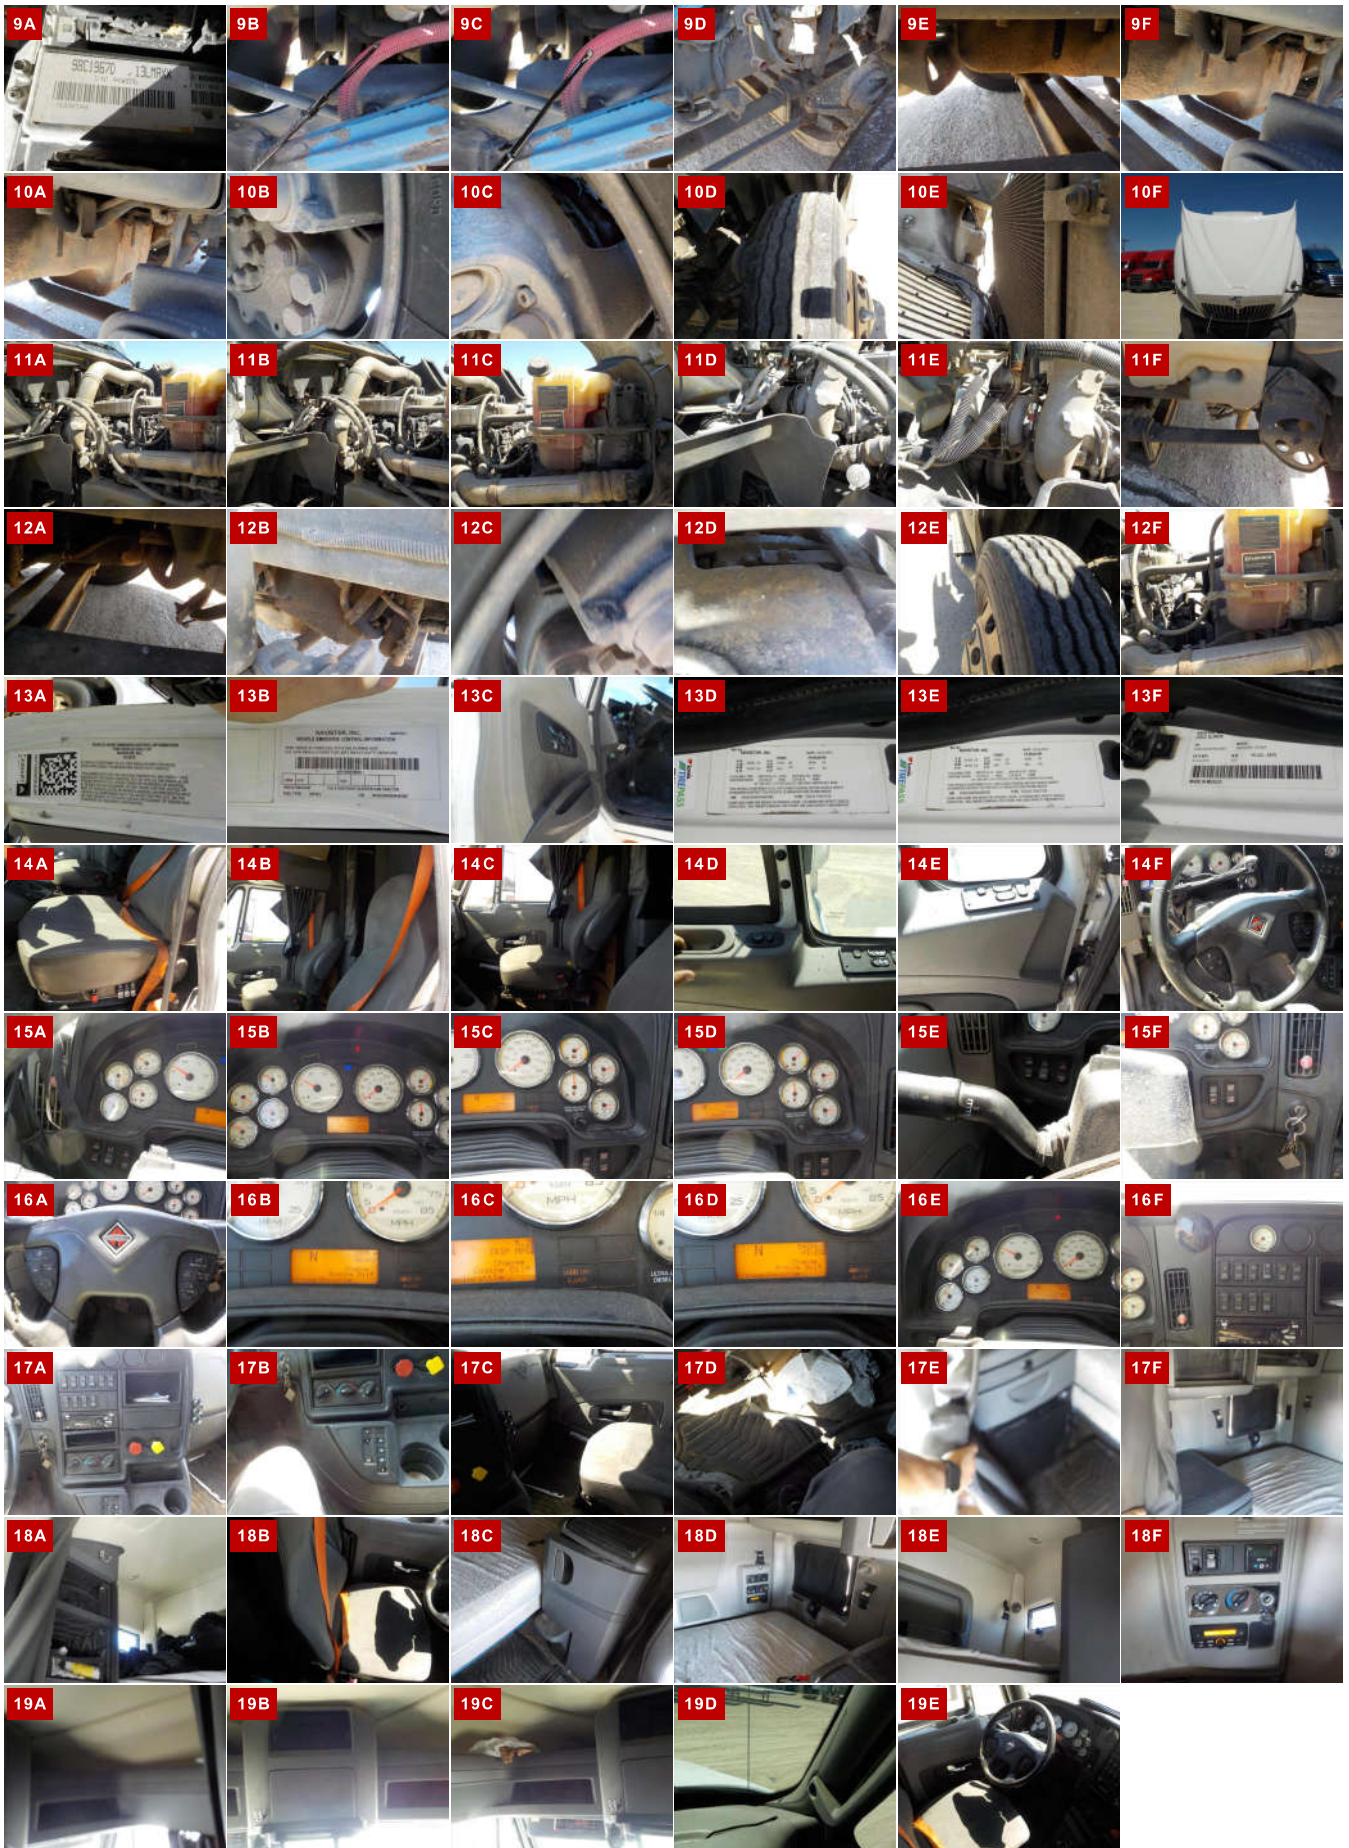
REPORT PHOTOS

DIAGNOSTICS	1 ACTIVE AND 11 INACTIVE CODES - SEE ATTACHED REPORT
PAINT	VARIOUS CHIPS AND SCRATCHES
HOOD	RIGHT SIDE SPOT MIRROR MISSING
HOOD	HOLES FROM PREVIOUS INSTALLED EQUIPMENT - RIGHT SIDE FENDER
MUD FLAP	RIGHT SIDE MISSING
SIDE FAIRINGS	MISSING TRIM STRIPS
SEATS	UPHOLSTERY DIRTY AND WORN.
TIRES	2 TIRES, WORN BELOW 10/32. LRR OUTSIDE TIRE IS FLAT
